**LG Chem, Ltd.**

July 30, 2020

**RE: In the Matter of the Commission's Inquiry of Arizona Public Service Battery Incident at McMicken Energy Storage Facility Pursuant to AZ Administrative Code R14-2-101. (Docket No. E-01345A-19-0076)**

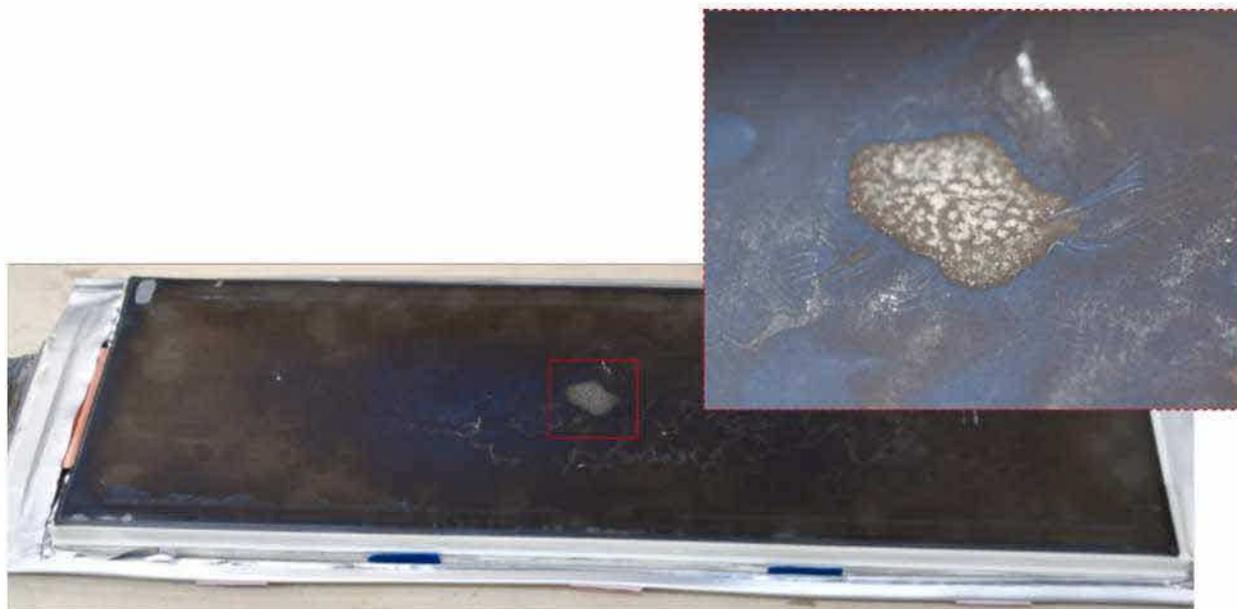
During various inspections associated with this matter, deposits were found on the negative electrode and adjacent separators of LGC JP3 cells from the McMicken and Festival Ranch BESS'. Figure 1 shows an example of one of these deposits.

Figure 1 Non-conductive negative electrode deposits.

Contrary to this pre-mature conclusion, Exponent and LG Chem independently measured the electrical conductivity of similar deposits extracted from cells not involved in the incident using two different methods and shared those results with all interested parties. The results of these measurements showed that deposits of this type are non-conductive and are unlikely to be pure lithium metal. It is impossible for a non-conductive deposit to establish an internal cell short circuit, carry current, resistively heat and cause thermal runaway.

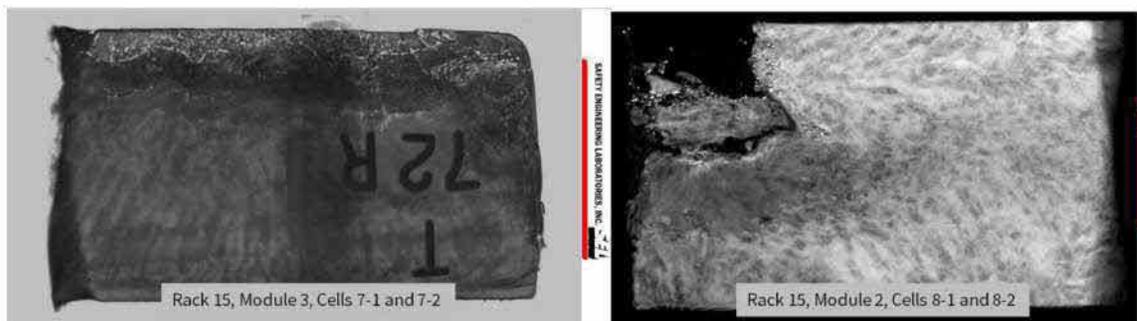
Exponent was provided with computed tomography (CT) X-ray data of twenty-one cell pairs from Modules 1 – 13 in Rack 15 for analysis. The analysis included Cell 7-2 which others have suggested suffered an internal short circuit, initiating thermal runaway. The data was analyzed with the intent of understanding any damage patterns that would help determine the root cause failure of Rack 15. The data is not consistent with an initiation from an internal short circuit but is consistent with an attack on the cells from an intense external heat source.

Figure 3 Representative 3D (left) and 2D (right) images of extensive cell damage in Rack 15.

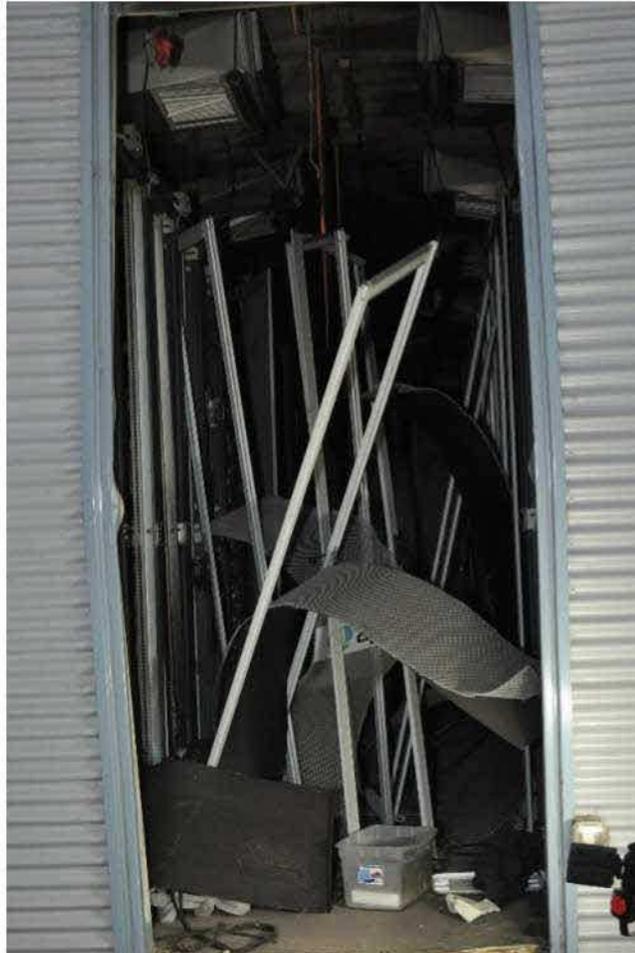
The hallway in the container separating the two sets of module racks was filled with debris (see Figure 14 through Figure 16) after the incident and was not accessible. In Figure 16, the sampling tube for the very early smoke detection apparatus (VESDA) can be seen hanging down because of heat exposure. It was noted that artifacts stored in the vacant racks, close to the door were consumed by fire.

Figure 14 The hallway separating the odd numbered and even numbered module racks.

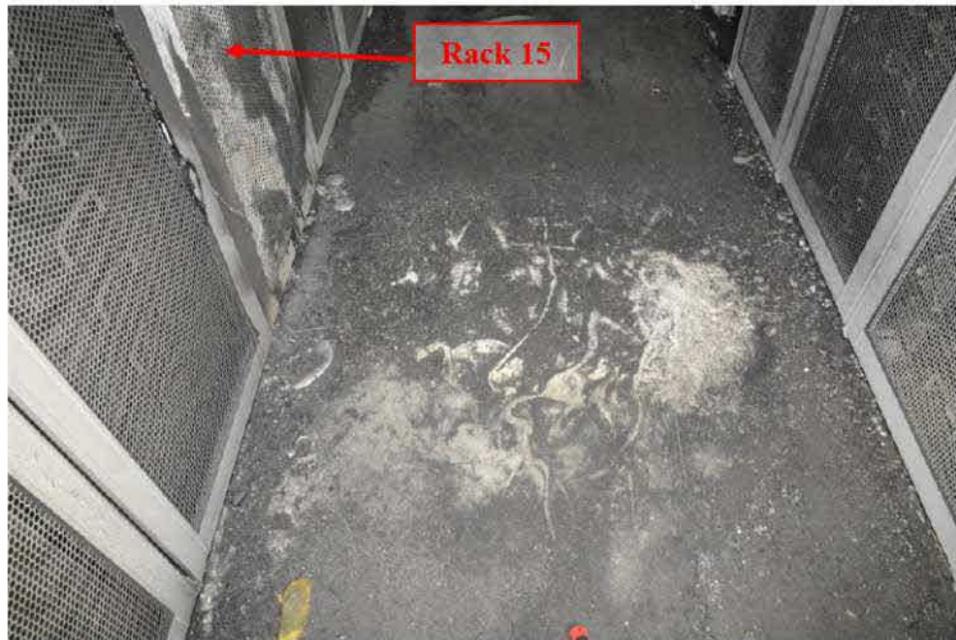
Exponent did not enter the container until most undamaged modules had been discharged. However, Exponent was provided with photographs prior to the removal of many components. The burn damage was concentrated near and around Rack 15.

Figure 17 Photograph showing the hallway and lower areas of racks. Rack 15 shows the most significant heat damage.

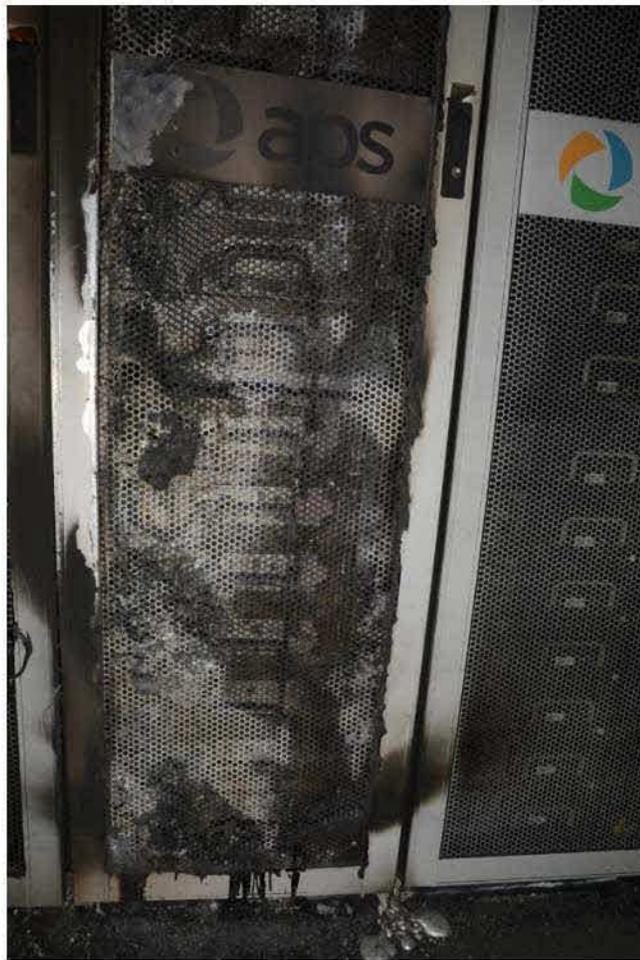
Figure 18 Photograph showing heat damage to the lower-middle section of Rack 15.

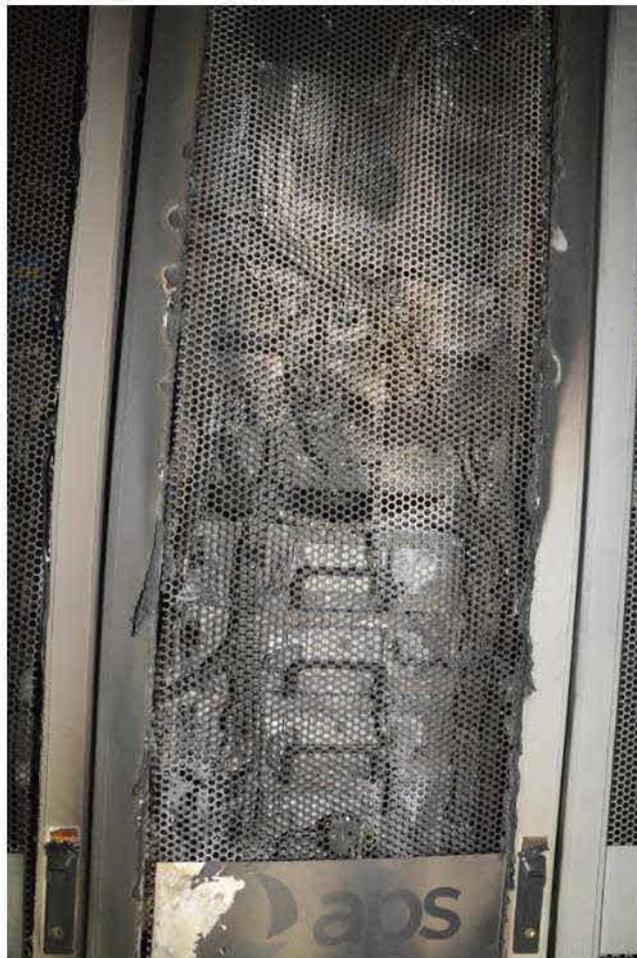
Figure 19 Photograph showing heat damage to the middle-upper section of Rack 15.

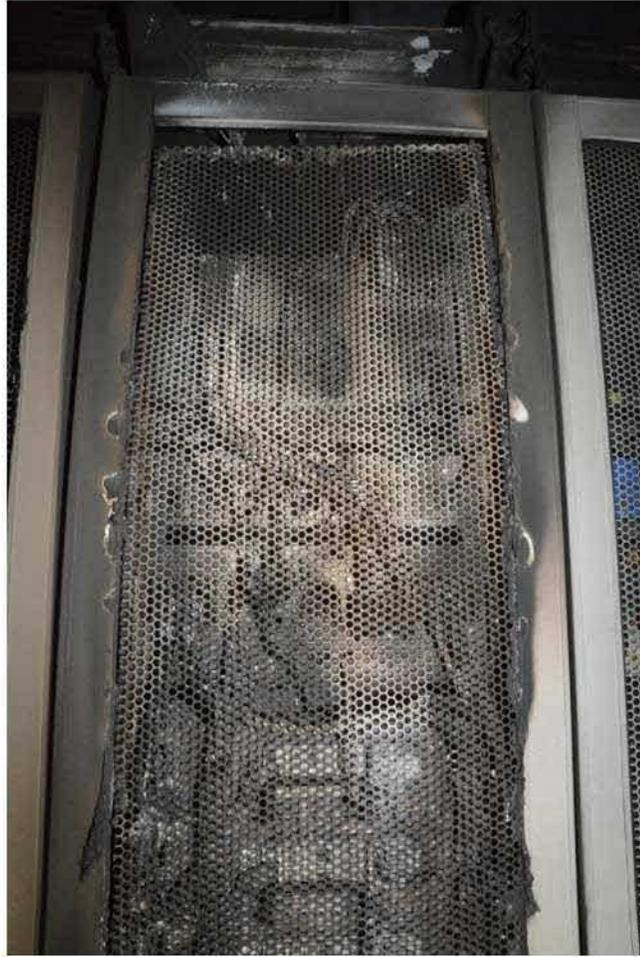
Figure 20 Photograph showing heat damage to the upper section of Rack 15.

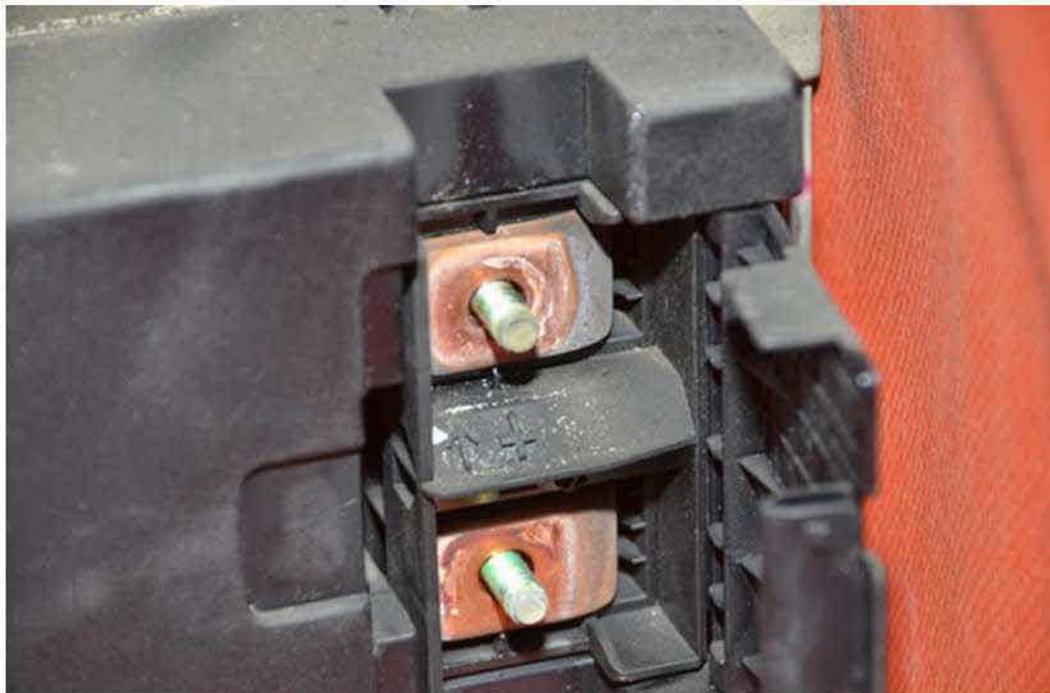
While modules were being disconnected to be removed from the BESS for discharge, a few of the external jumper cables which connected the modules together were observed to be loose. On at least one module, there appeared to be a white residue and discoloration on the terminals (see Figure 22). Additional observations relating to this are described later in the report. Exponent was not permitted in the BESS to observe disassembly.

Figure 22 Likely corrosion observed on module terminals.

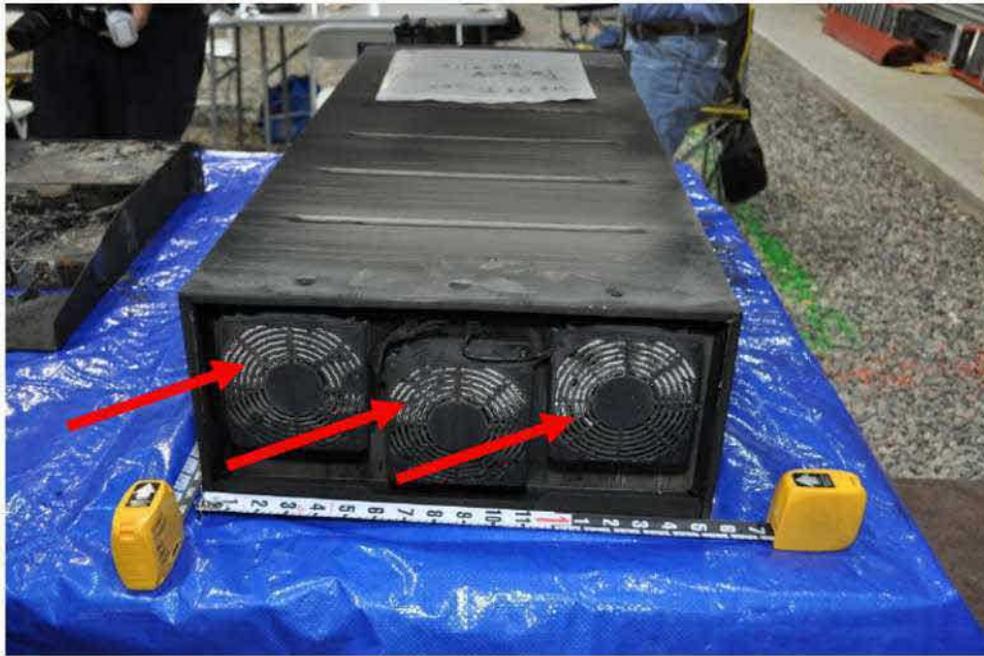
Figure 57 PCS (Inverter) from Rack 15 with clogged fan vents.

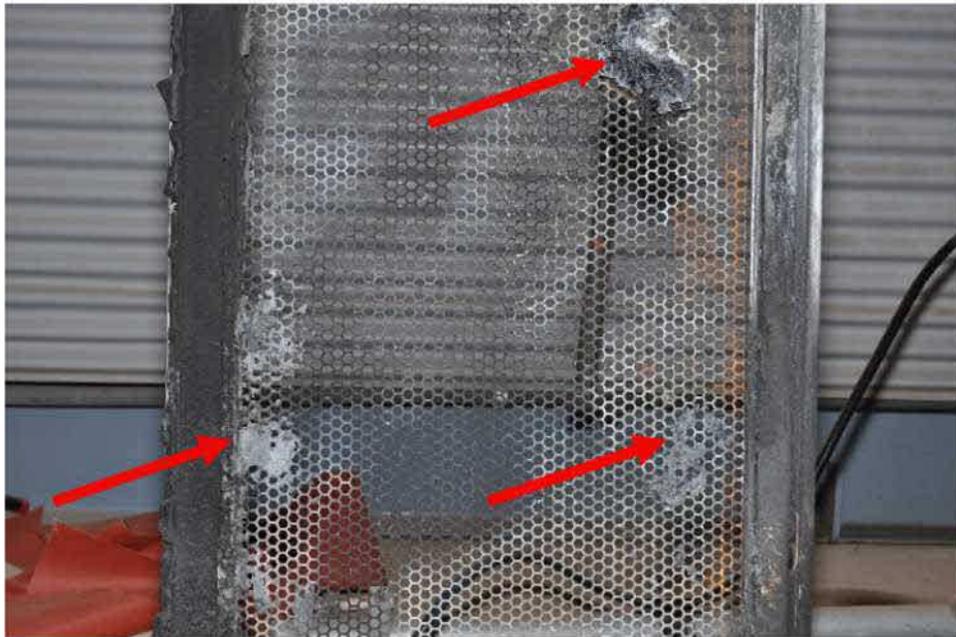
Figure 60 Rack 15 door with debris attached to the screen of the door.

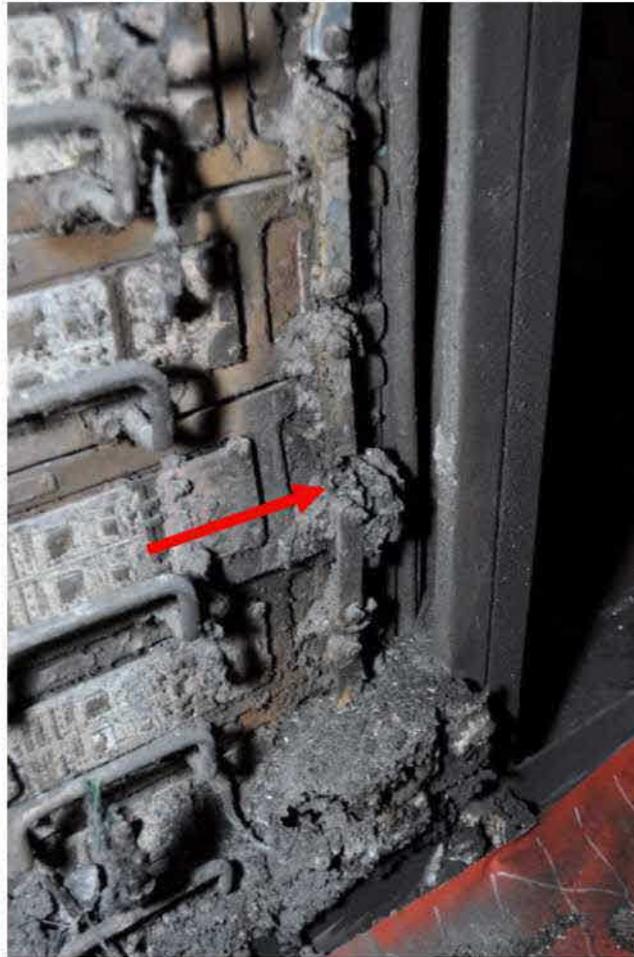
Figure 62 Rack 15, Module 3 - the red arrow points to the arc damaged positive terminal and busbar.

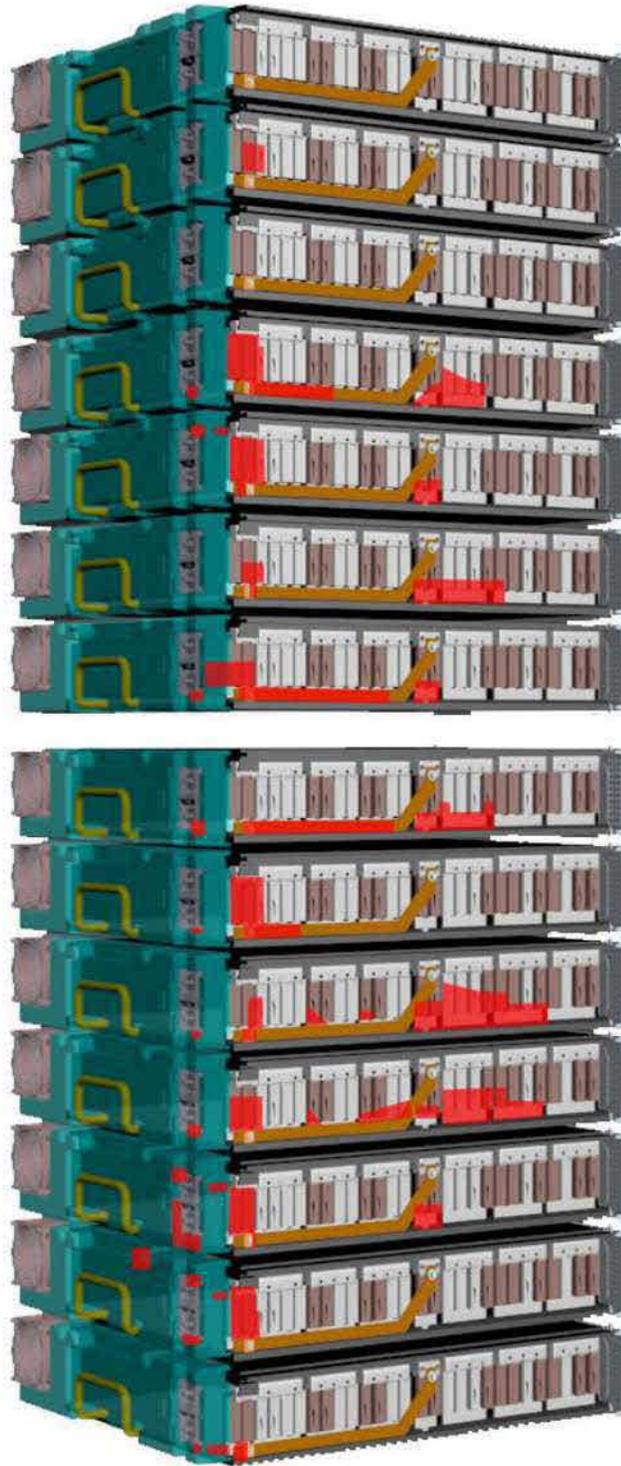
Figure 67 The front and right view of Rack 15. The red marked areas show the arcing at the positive and negative terminals, internal busbars, cell tab interconnects as well as on the metal front cover plate of Module 2.

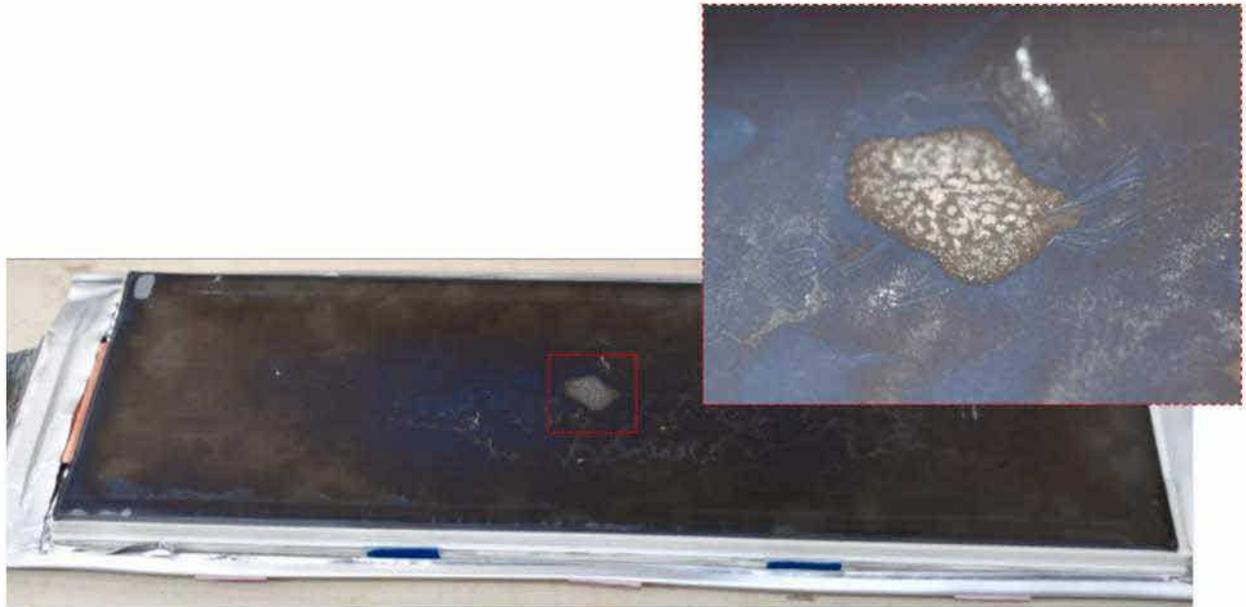
Figure 73 Non-conductive negative electrode deposits.

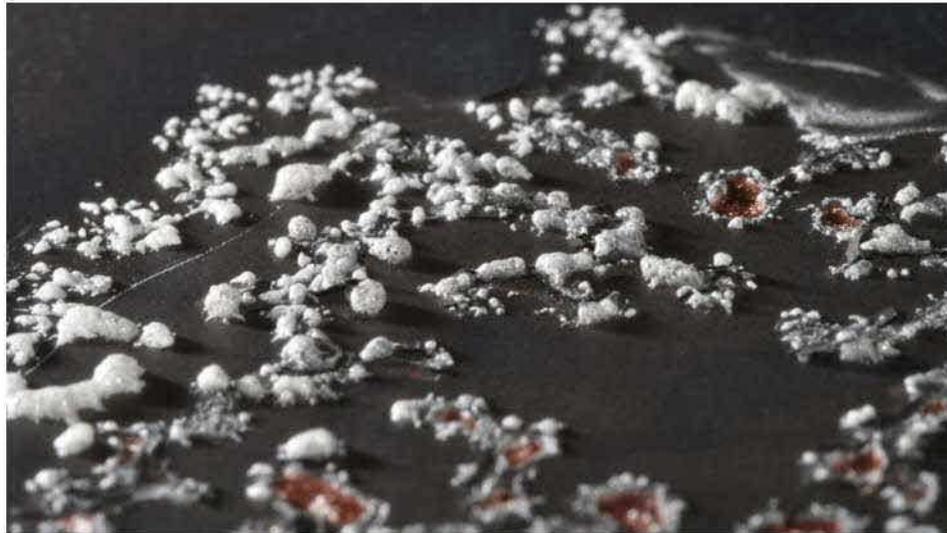
Figure 76 A deposit found during a multiparty inspection of a LGC JP3 cell showing behavior consistent with the reaction of lithium upon exposure to air. The white color and bubbly morphology are consistent with the exothermic reaction of lithium metal with water.

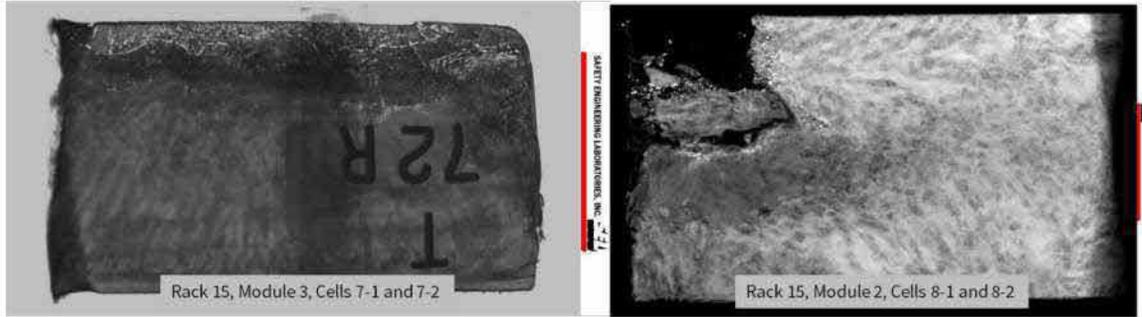
Figure 79 Representative 3D (left) and 2D (right) images of extensive cell damage in Rack 15. Almost all the cell pairs exhibited extensive damage to the electrodes. The damage to the cell pairs was observed to be in various combinations of large regions containing bright spots and missing electrodes as a result of the damage. The vast majority of the damage was concentrated on the cell edges. In some cases, the exterior damage spanned both cells in the pair.

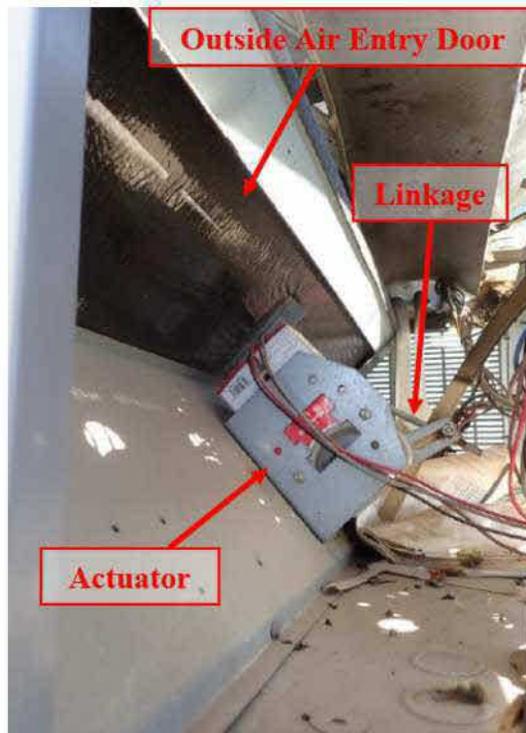
Figure 86 Economizers were found installed on HVAC units.

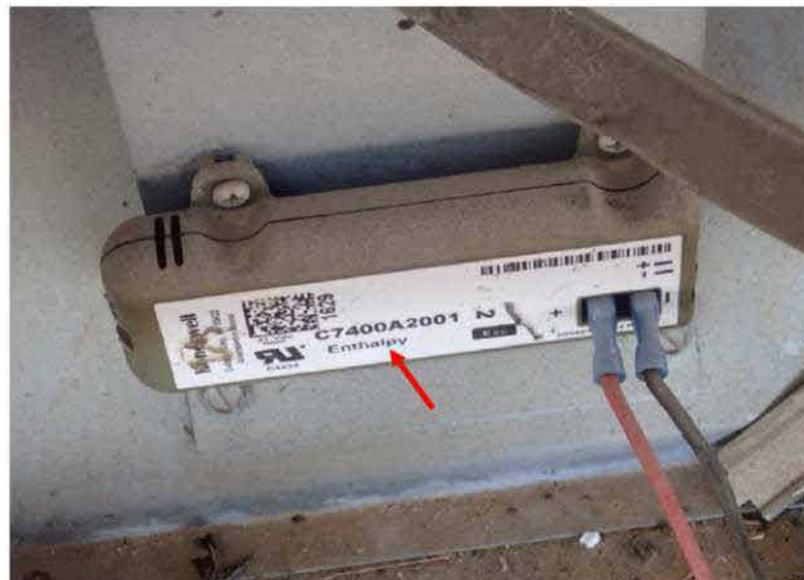
Figure 87 Enthalpy sensors were found installed and connected to the economizer control board in the HVACs.

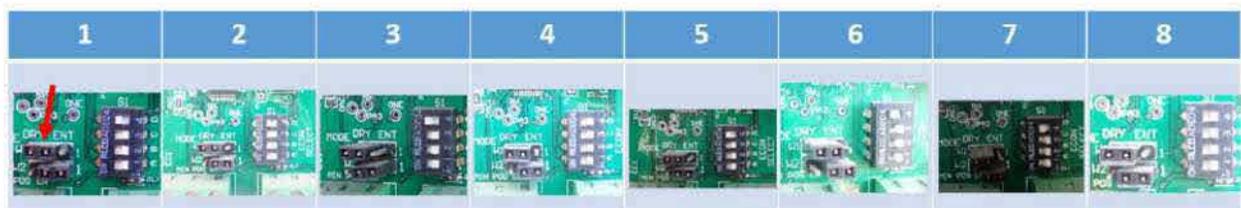
Figure 88 Photographs of all eight HVAC economizer control boards showing they were configured to receive dry bulb temperature sensor signals.

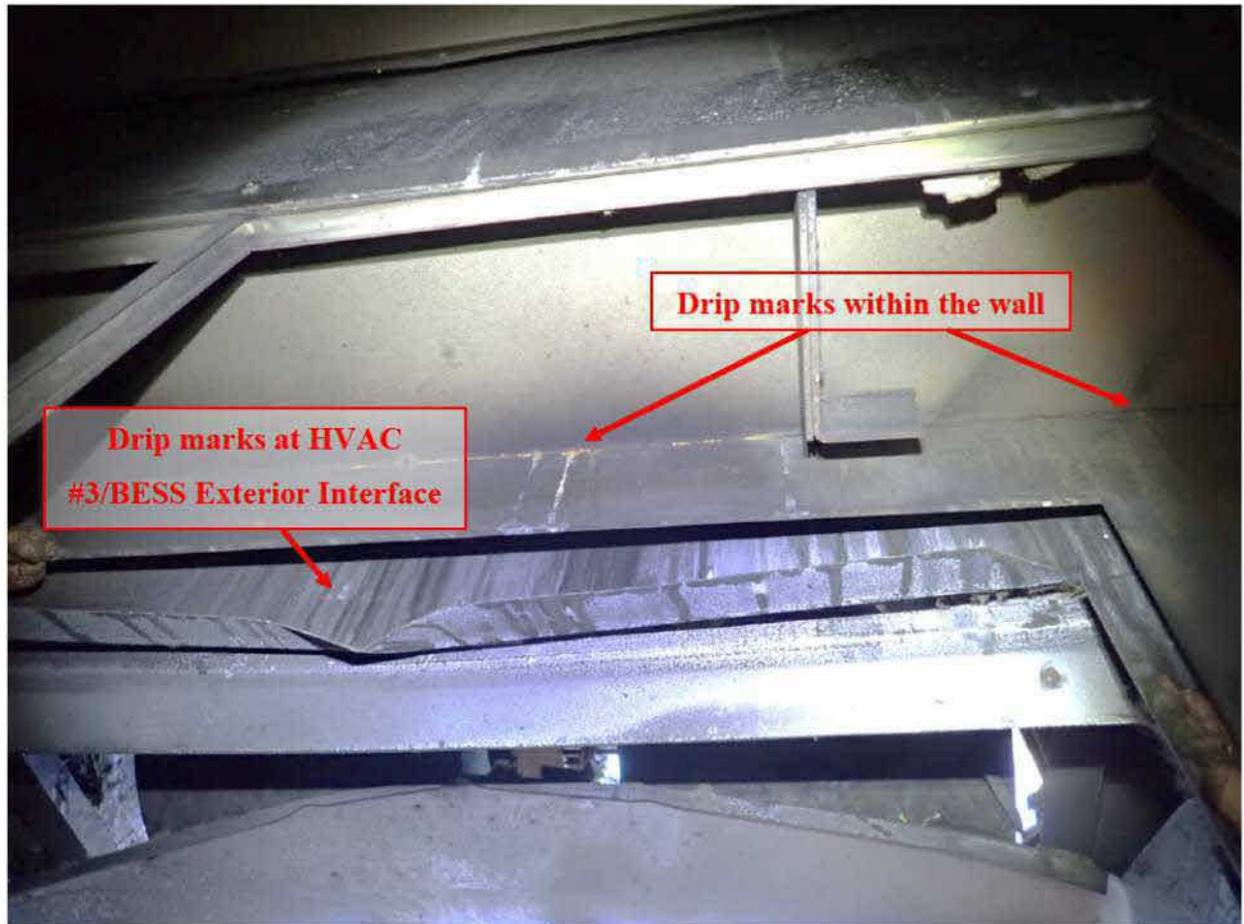
Figure 89 Evidence of liquid marks observed on the inside face of the HVAC #3, which mates with the exterior BESS wall. This photograph was taken as viewed through the return air cutout in the wall, adjacent to Rack 15.

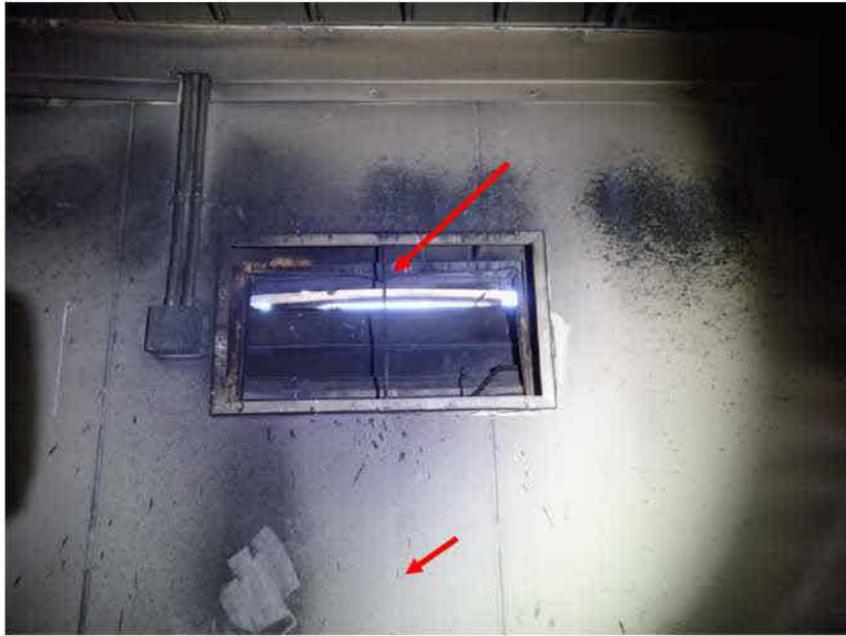
Figure 90 Liquid drip marks observed on the BESS inside wall, adjacent to Rack 15.

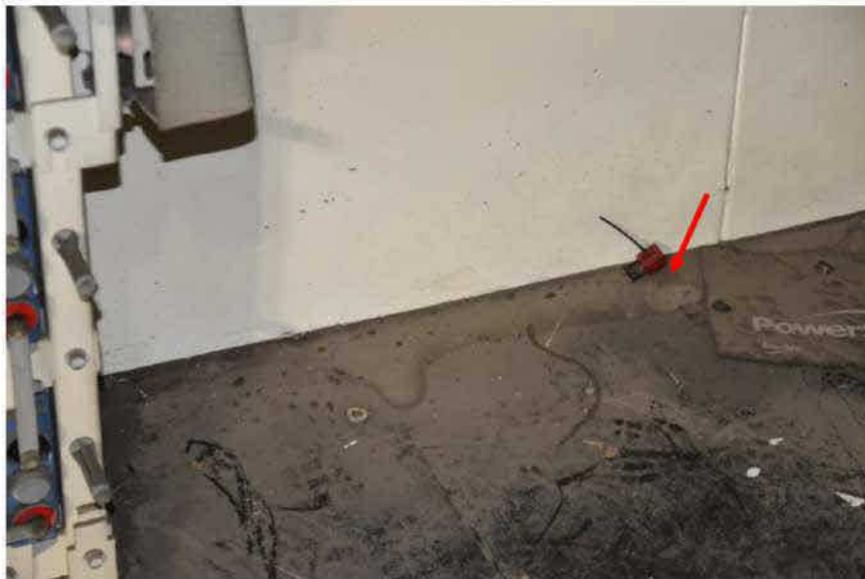
Figure 91 Dried liquid marks on the same inner wall of the BESS towards the corner.

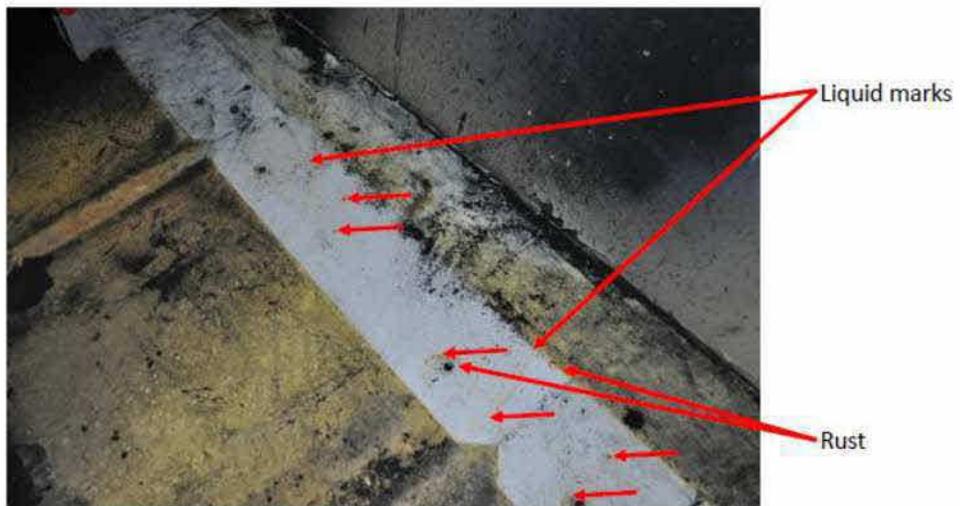
Figure 93 Photograph showing liquid marks and what appears to be residue of rust on the floor underneath Rack 15.

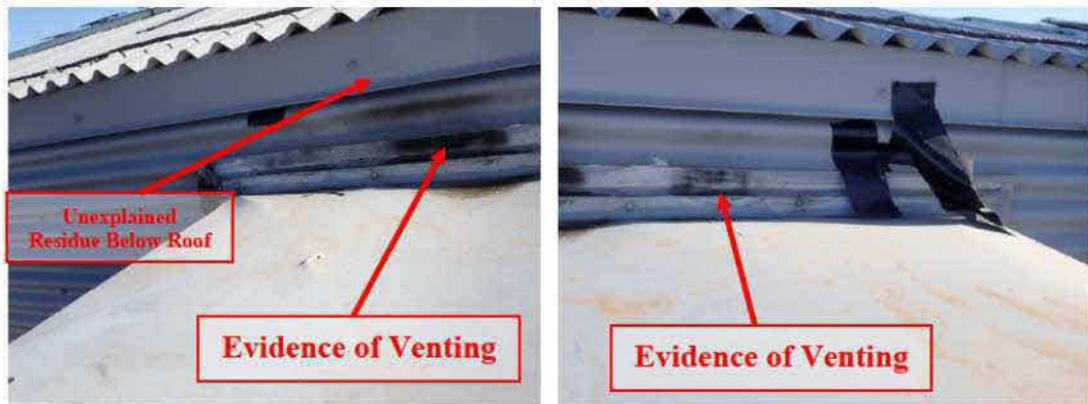
Figure 94 Photographs taken at the top of HVAC #3 where it mates with the BESS. Black residue is observed adjacent to the flange which is likely due to venting during the event, but there is also an unexplained residue dripping from underneath the corrugated roof.

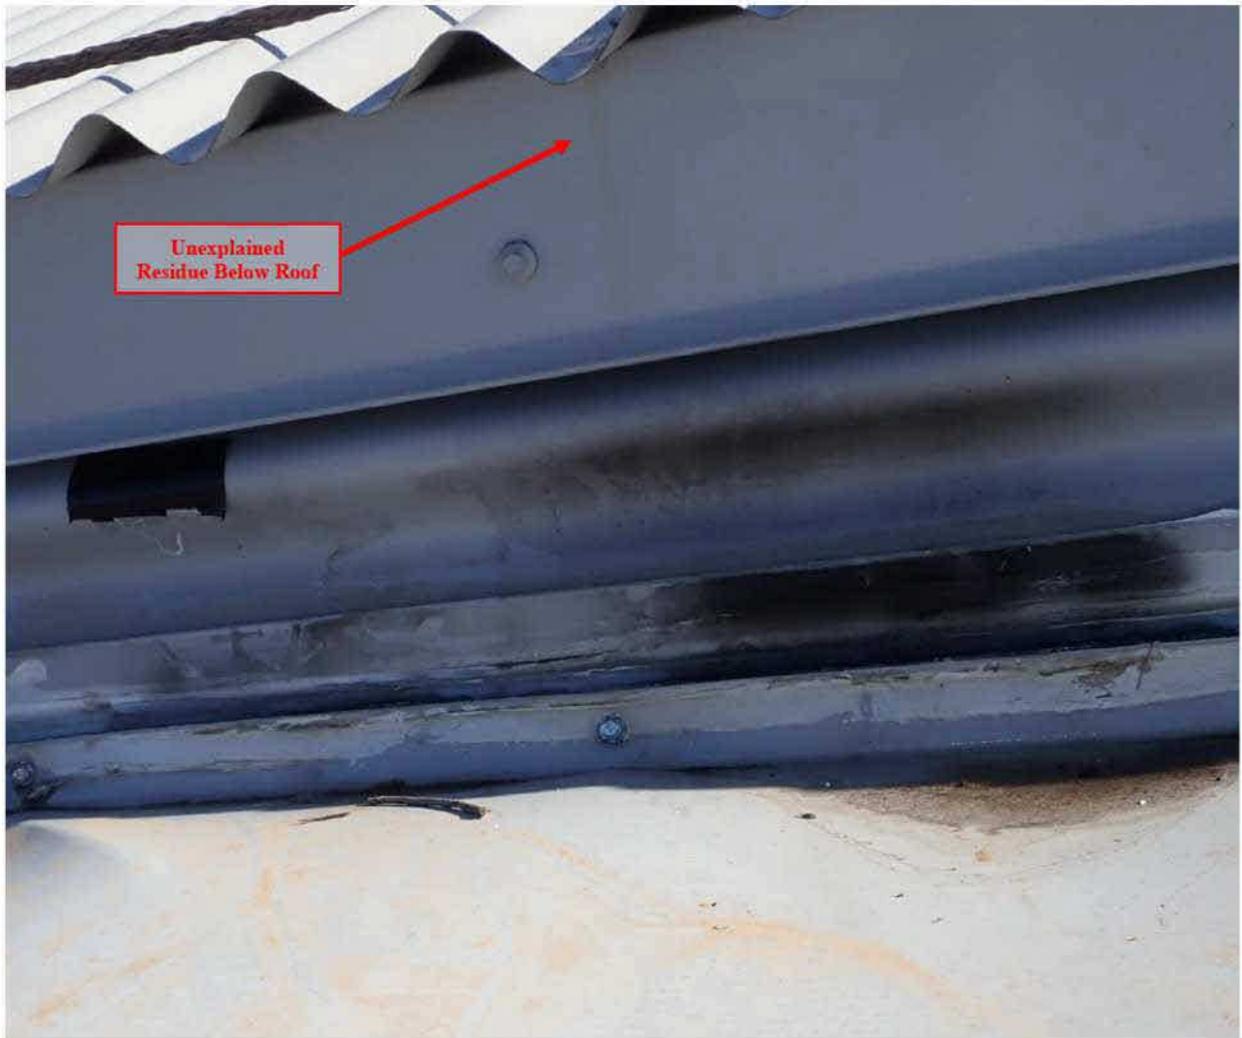
Figure 96 Zoomed in view of the left photograph in Figure 94. There is an unexplained residue emanating from underneath the corrugated steel roofing material.
