**LG Chem, Ltd.**

July 30, 2020

**RE: In the Matter of the Commission's Inquiry of Arizona Public Service Battery Incident at McMicken Energy Storage Facility Pursuant to AZ Administrative Code R14-2-101. (Docket No. E-01345A-19-0076)**

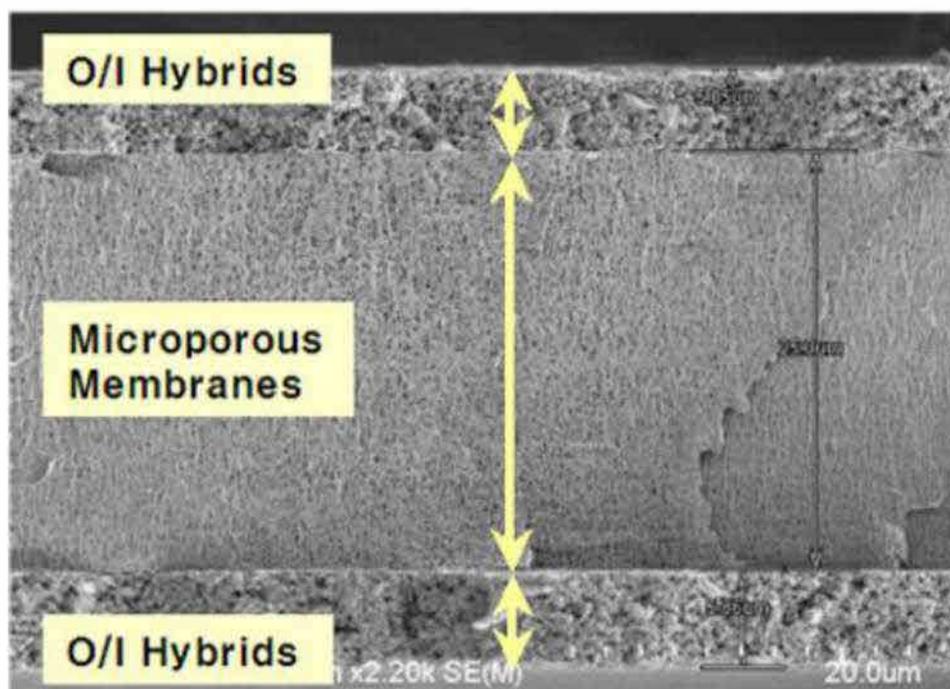
Figure 2 Cross-section of the SRS separator used in the LGC JP3 cells.

Further, the LG Chem SRS separator was specifically designed to be highly resistant to deposited lithium short circuiting. The SRS separator is a hybrid design comprised of a microporous polymeric membrane coated on both sides with relatively dense organic/inorganic (O/I) protective layers with very small pore sizes. A cross-sectional view of the SRS and its layers is shown in Figure 2.

The SRS separator has two complementary features that address different risks associated with lithium plating. First, the pore diameters of the O/I layers are small enough to limit the size of any lithium growing through the separator effectively limiting the ability to carry current sufficient to heat the cell to thermal runaway. Second, the mechanical strength provided by the I/O layers has been shown to resist tearing at loads that are much higher than what can be produced between the unconstrained electrode layers of a lithium-ion pouch cell. The combined

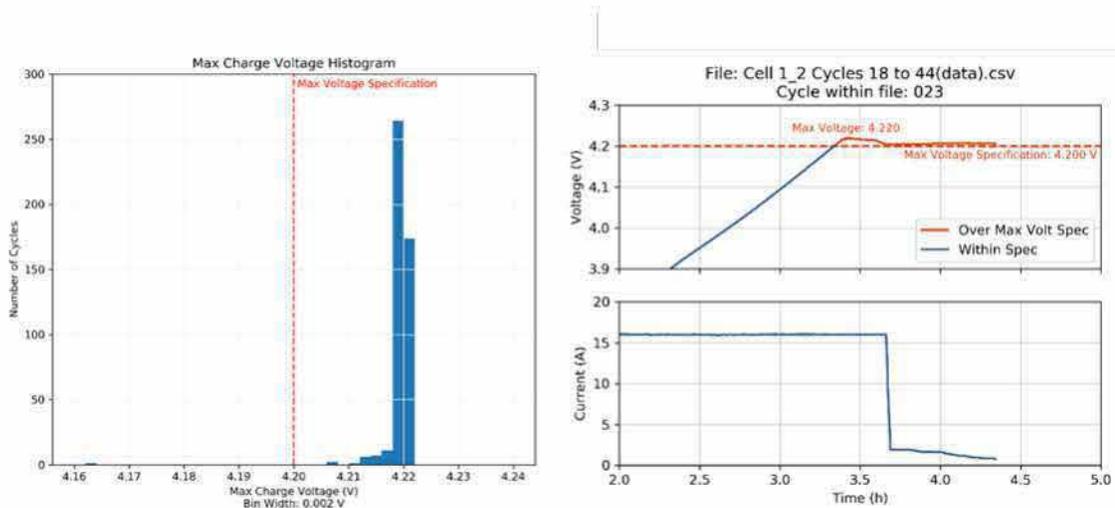
Figure 4 (a, left) A histogram of the number of cycles that had various max charge voltages. (b, right) Current and voltage profiles for the end of charge for a typical cycle exhibiting overvoltage on charge.

- The maximum charge current was varied between 8.2A and 16.5A and was unstable at any chosen current during the 463 cycles of the experiment.
- The files describing cycle 401 and after are labeled “constrained”. SEL has not provided any further explanation about the nature of the constraint (electrical or physical) or why it was applied after 400 cycles.
- The charge voltage consistently exceeded the maximum charge voltage specified by LG Chem<sup>3</sup>. Figure 4 (a) clearly shows that most cycles exceed the maximum charge

voltage, in most cases by at least 18mV. Figure 80 (b) shows the charge voltage and current for a typical cycle exhibiting overvoltage behavior.

- The transition from the constant-current (CC) charge to constant-voltage (CV) charge was uncharacteristic of typical cell cycling equipment suggesting that the equipment SEL used for this cycling test was not designed for and was simply incapable of accurately performing an ordinary charge algorithm on this cell.
- The ratio of charge capacity to discharge capacity (coulombic efficiency) was extremely poor but the cycling data or the CT data does not indicate a problem with the cell. This further supports that the equipment SEL used to cycle this cell was either inaccurate, improperly configured, or incapable of performing this test.

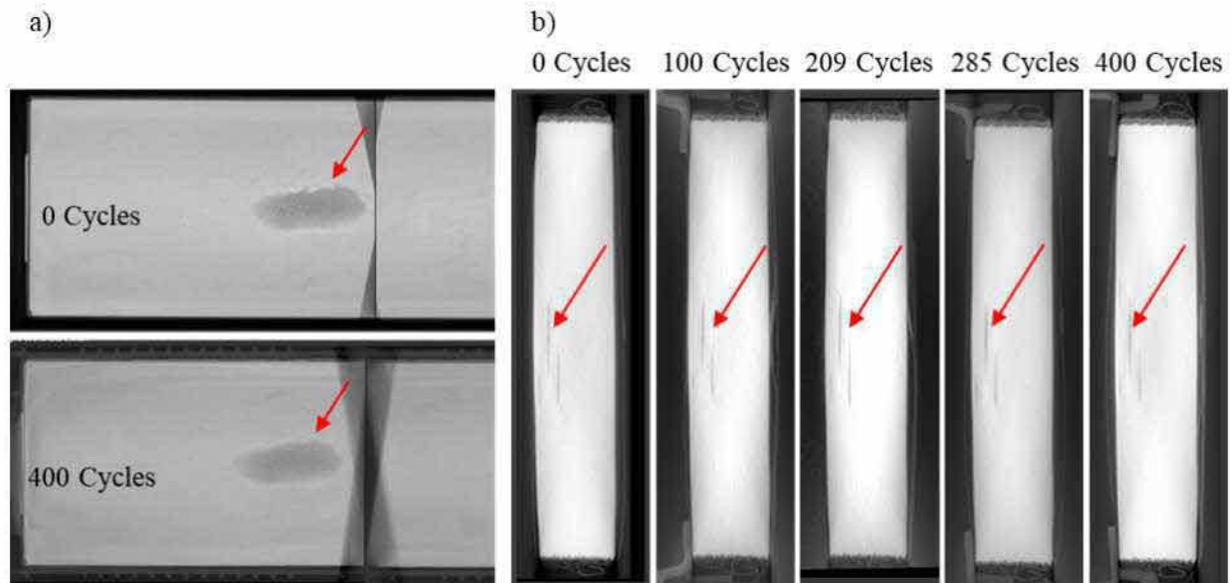
Figure 5 (a) Planar and (b) cross-sectional views of one representative feature tracked throughout cycling.

In addition to the cycling data, SEL provided ten sets of CT data consisting of scans of the cycled cell at five cycling intervals (0, 100, 209, 285 and 400 cycles). CT scans conducted prior to cycling showed the uncycled cell contained several features consistent with deposits on the negative electrode, similar to those found to be non-conductive (as discussed above). These features did not change in size or shape during the 400 cycles, see Figure 5. Additionally, despite the issues with the cycling protocol noted above, no measurable swelling of the pouch or localized swelling around the deposits were observed over the 400 cycles tracked.

In spite of the cycling data showing overcharge of the cell, a condition that would promote lithium plating, the CT data do not support the growth of the observed internal cell features as a function of cycle count and subsequently do not support the growth of lithium deposits capable of causing a short circuit that may result in thermal runaway. Discussion of these data is absent from the DNV GL report representing another instance where available information, contradictory to the assertion that an internal cell fault is responsible for thermal runaway of Rack 15, was ignored.

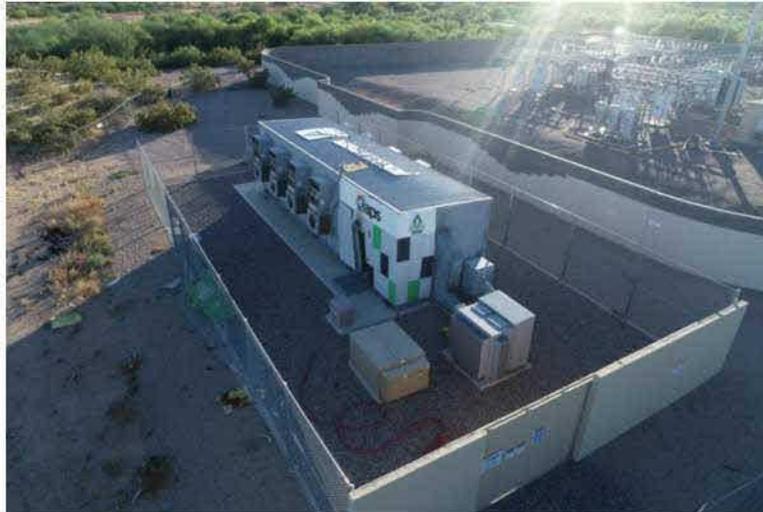
Aerial photographs of the BESS taken after the incident and prior to a joint scene examination are shown in Figure 7 and Figure 8. The burn damage is confined to the BESS container.

Figure 7 Aerial photograph of the BESS and adjacent substation taken prior to the first joint scene examination<sup>9</sup>.

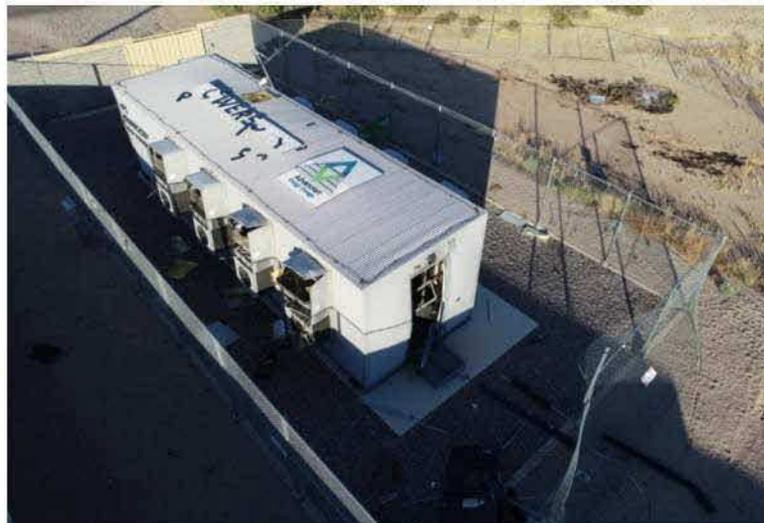
Figure 8 Aerial photograph of the BESS taken prior to the first joint scene examination<sup>10</sup>.

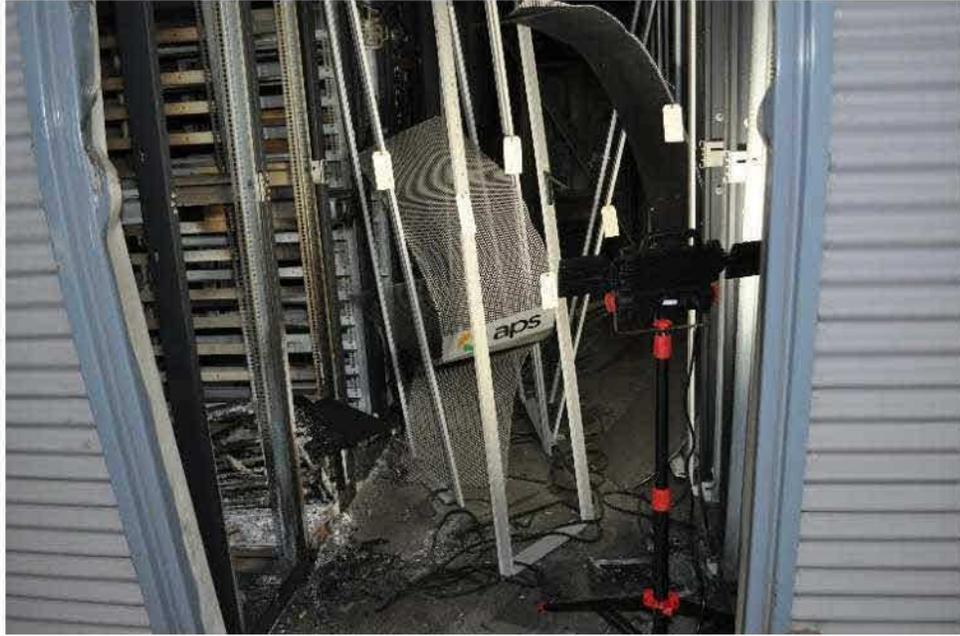
The hallway in the container separating the two sets of module racks was filled with debris (see Figure 14 through Figure 16) after the incident and was not accessible. In Figure 16, the sampling tube for the very early smoke detection apparatus (VESDA) can be seen hanging down because of heat exposure. It was noted that artifacts stored in the vacant racks, close to the door were consumed by fire.

Figure 15 The hallway.

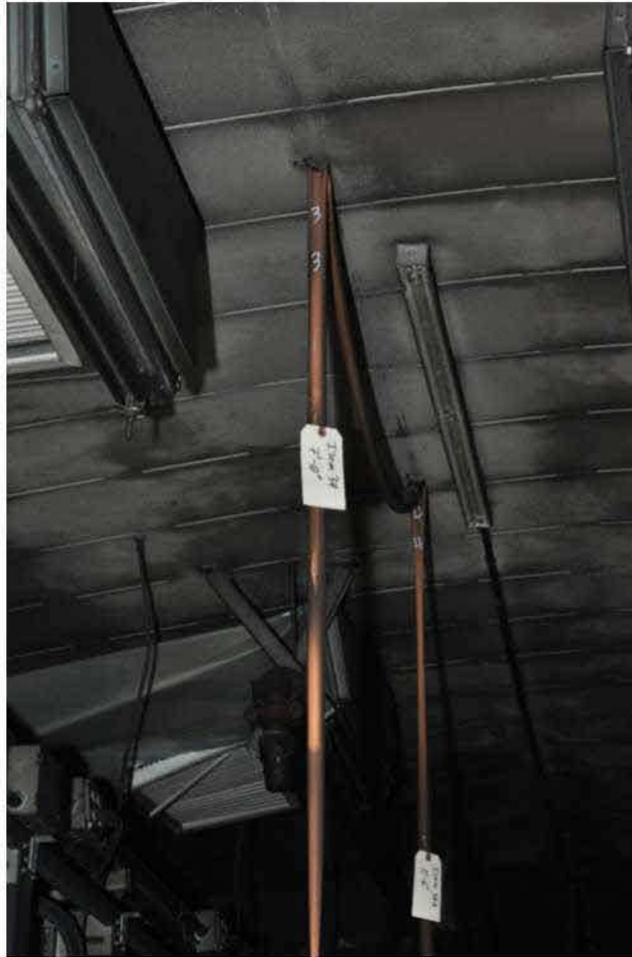
Figure 16 The ceiling above the hallway, showing the VESDA sampling tube, lighting, and HVAC ductwork.

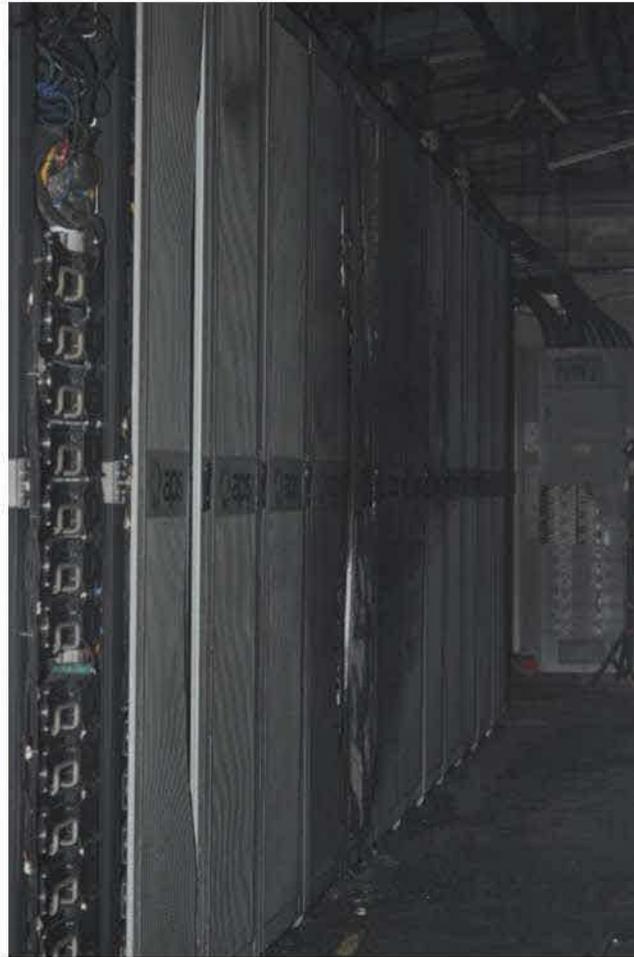
The debris was removed, logged, and inspected. Once the hallway was cleared, the racks were inspected. The rack identified as the most likely origin was Rack 15 (see Figure 17). All the racks in the container sustained smoke damage. Racks 13 and 17 were adjacent to Rack 15 and sustained minor thermal damage in addition to smoke damage. Rack 15 showed fire damage extending from the bottom of the door to the top of the rack (see Figure 18 through Figure 20). The wiring conduit, wiring trays and general wiring above Rack 15 also sustained significant fire damage. Rack 15 was left intact.

Figure 21 The odd numbered racks which includes Rack 15.

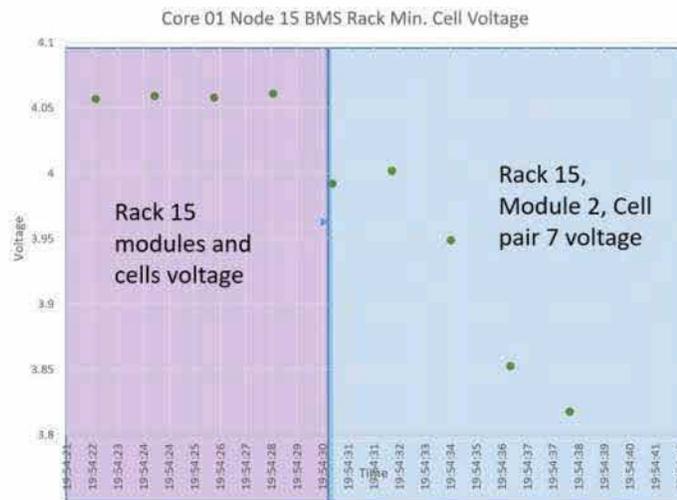
- The sample rate of data that was logged was slow at 1 sample for every two seconds (see Figure 23 and Figure 24). The data logger takes a snapshot of the minimum cell voltage data every two seconds, similar to a photo that is taken – this means that the data does not indicate a rising, falling or static value.

Figure 24 The data captured for the minimum voltage in the system at the time of the incident.

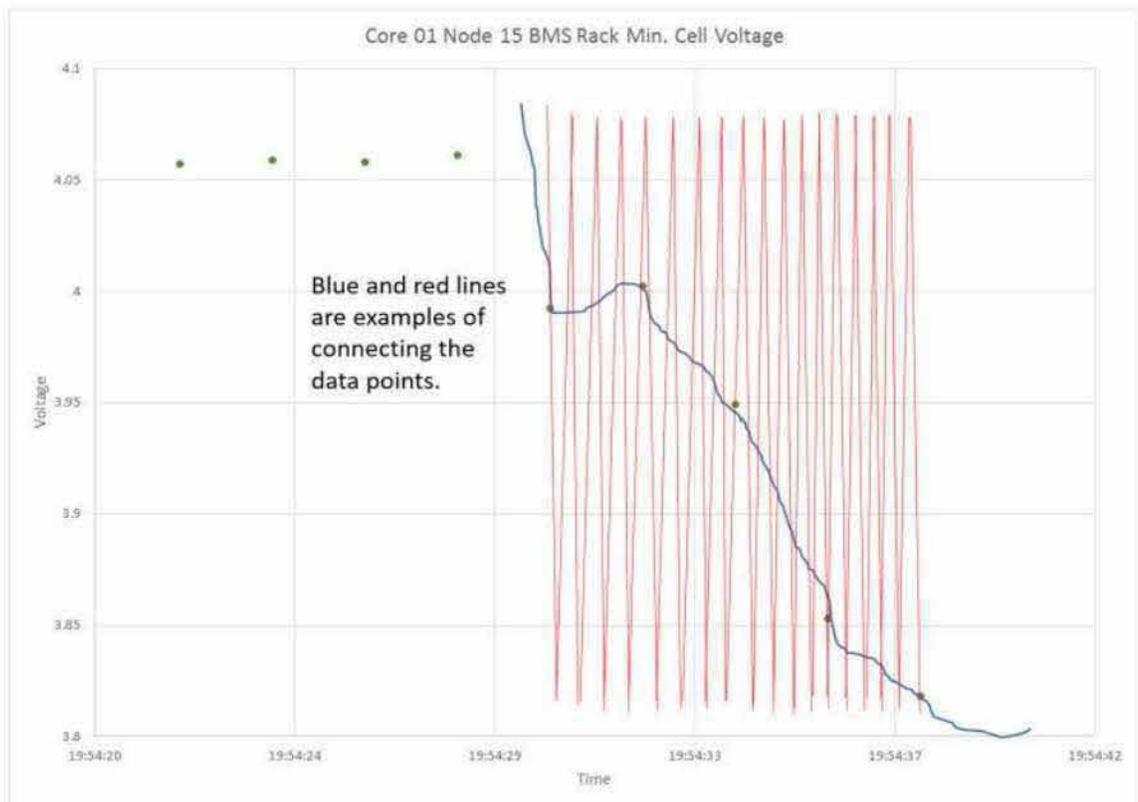
Figure 25 Example of signal aliasing using the incident excursion data points.

An example of signal aliasing is shown in Figure 25. The sample rate is 0.5Hz which is too slow to accurately recreate a higher frequency signal. Excel tends to connect the data points based on the type of graph template that was selected. This can result in an undue confidence in understanding the true signal characteristics. The blue profile was artificially created using the data points. The red profile was also artificially created from the data points. Hence, the data points do not provide information on the frequency of the signal and hence by signal association, a specific failure mode cannot be identified. The data of the minimum voltage during the incident is shown in Figure 25 and Figure 26 .

The slow data acquisition rate and the effects of aliasing limited the information of the voltage data of Module 2 Cell 7 pair. It is therefore not known (and unknowable) whether the voltage profile was a high frequency or a low frequency voltage event (see Figure 25) and hence it is unknown whether the profile was associated with arcing and rapid changes in the module cell voltages as a result of external arcing.

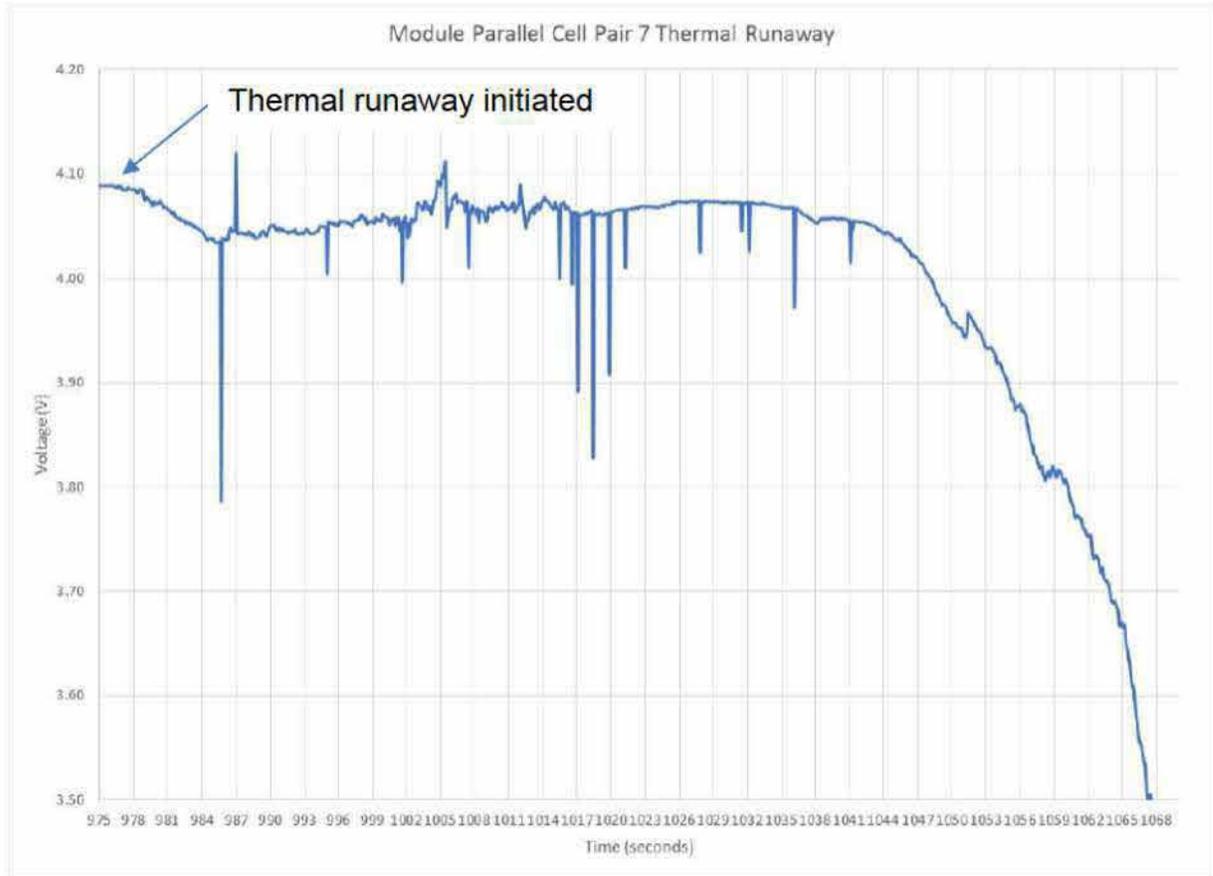
The test result (see Figure 34) shows that when one cell in the parallel cell pair goes into thermal runaway, the second cell will compensate for the parallel pair voltage and attempt to keep the cell pair voltage close to the original state of charge cell pair voltage. In the test the initial voltage after approximately eight seconds dropped from approximately 4.09V to 4.05V and took approximately 85 seconds to reach 3.8V. The intermittent voltage drops are likely to be instrumentation related and not to the cells themselves. To validate this voltage profile, the

Figure 33 Voltage profile of Cell 7 pair during thermal runaway event inside the module.

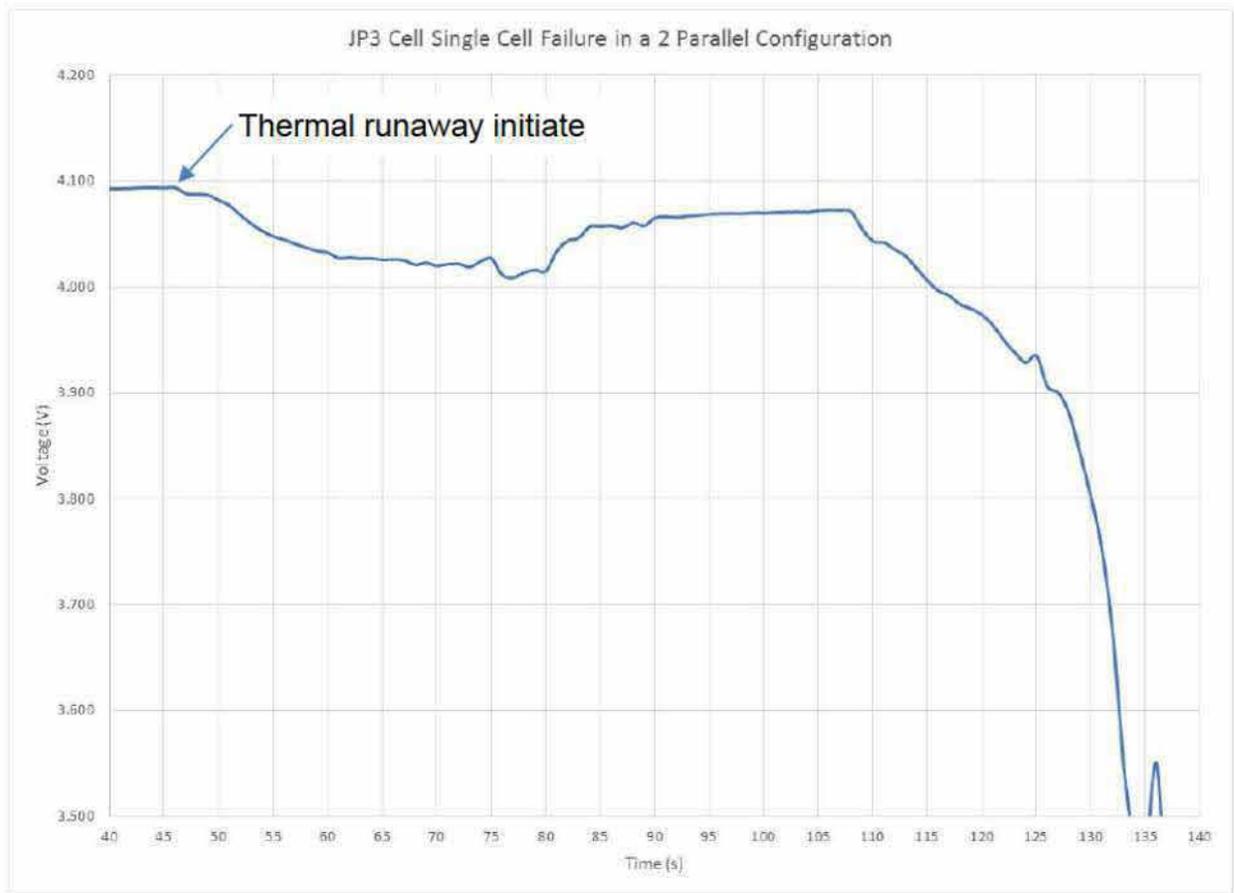
The test result (see Figure 37) shows that when one cell in the parallel cell pair goes into thermal runaway, the second cell will compensate for the parallel pair voltage and attempt to keep the cell pair voltage close to the original state of charge cell pair voltage. In the test, the initial voltage, after approximately eight seconds, dropped from approximately 4.09V to 4.05V and took approximately 83 seconds to reach 3.8V. This voltage profile is very similar to the module test voltage profile.

Figure 37 The voltage profile for a parallel JP3 cell pair thermal runaway event.

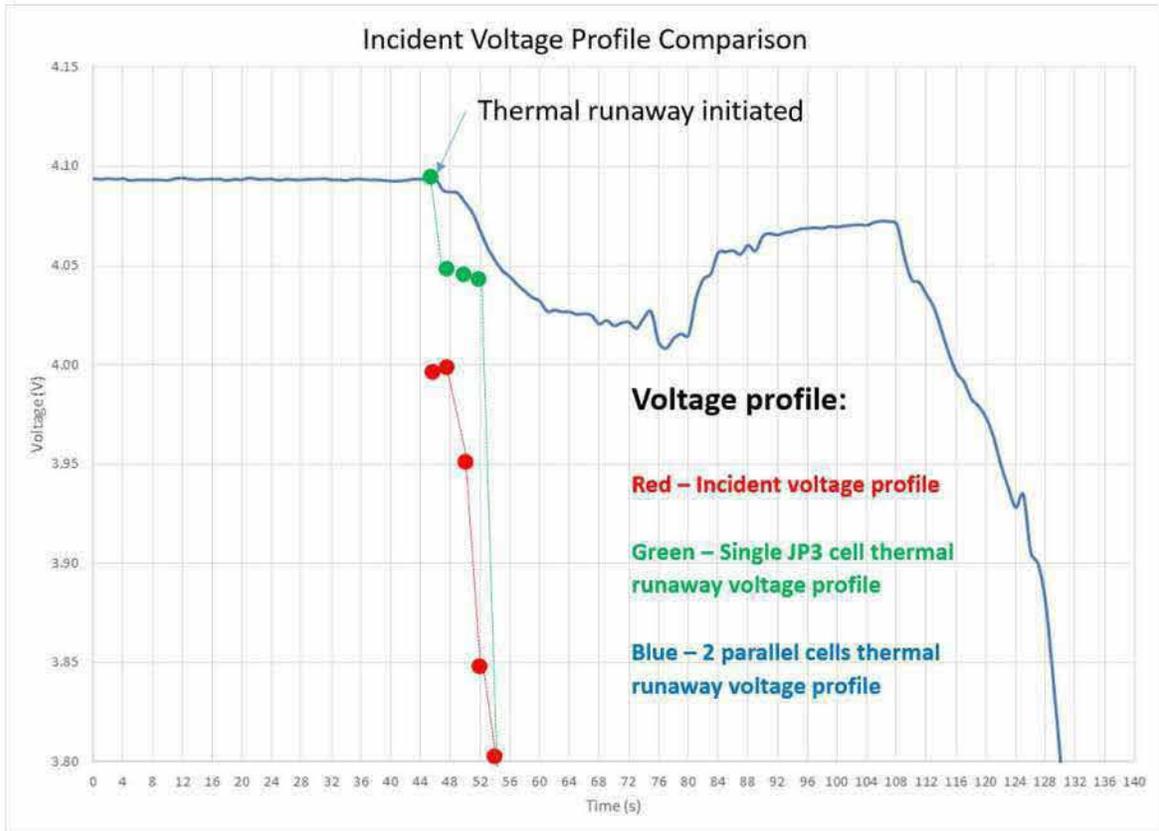
Figure 38 The incident and the cell level test thermal runaway voltage profile comparison.

In Figure 38 the red line is the incident voltage excursion. The blue line is the tested parallel cell with single cell thermal runaway event. Three tests, a single cell thermal runaway event (green data in Figure 38), a module level test and a parallel cell level test (blue data in Figure 38) show that the incident profile is not representative of the cell failure in a parallel cell pair configuration. Testing shows that the voltage profile for a single cell thermal runaway in a parallel configuration is closely reproducible, however this observation is based on limited sample testing. The same test should be conducted in a fully functional rack for further verification.

Based on the parallel cell test results, which matches the configuration in the incident, the incident voltage profile does not match the test result profile and hence it is unlikely that a single cell failure caused the observed voltage excursion. The single cell test, where a single cell was removed from a parallel cell pair in a module for testing, appears to have a somewhat

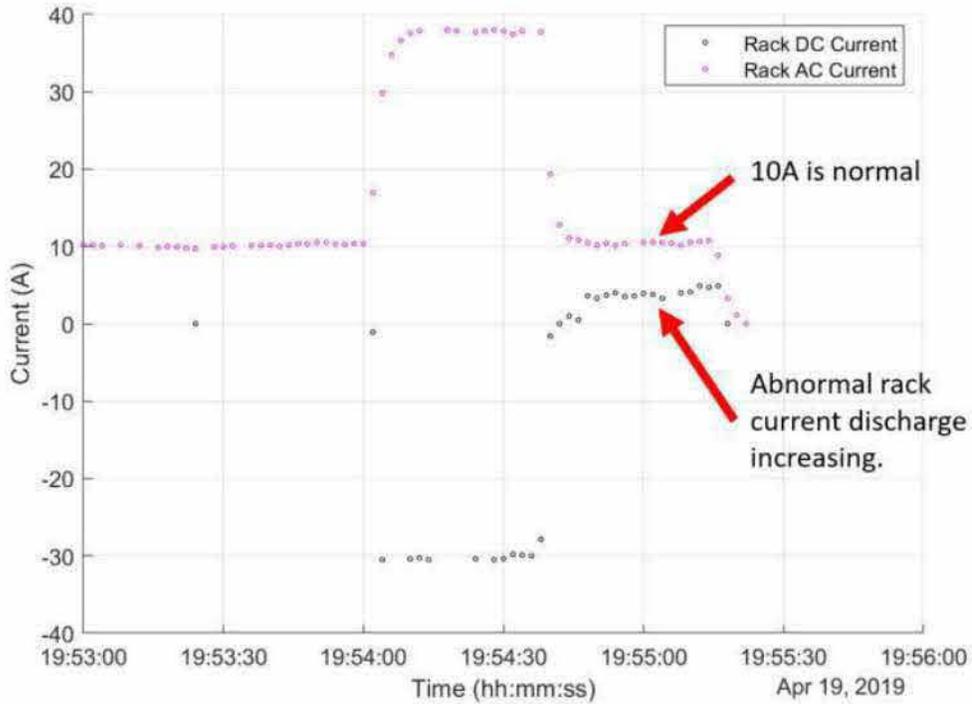
The incident current profile is shown in Figure 40 and is different. The Rack 15 current transitions from a charge (negative current) current to a discharge (positive current) current and continue to be present until Rack 15's breaker opens. When compared to the normal charge profile, this discharge current is abnormal. Again, signal aliasing likely does not show the actual current profile and hence current peaks could have been significantly higher between data points. When it is considered that the cells in Rack 15 are floating with respect to the rack (isolated from the rack), the only plausible way this current can be present is when there are two simultaneous electrical isolation faults in rack 15. This evidence supports a double electrical isolation failure due to the current measured by the current transducer located between modules 1-7 and modules 8-14.

Figure 40 The abnormal end of charge current profile prior and during the failure event.

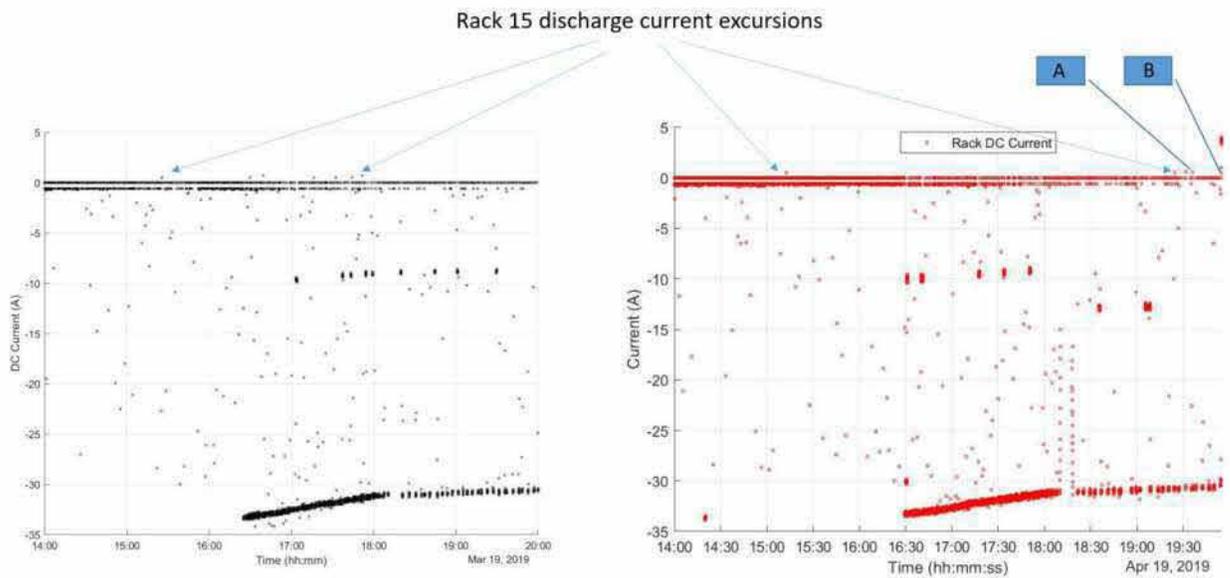
The charge current and unknown positive discharge current excursions were noted (see Figure 41) prior to the incident and should be further investigated.

Figure 41 Discharge current excursions.

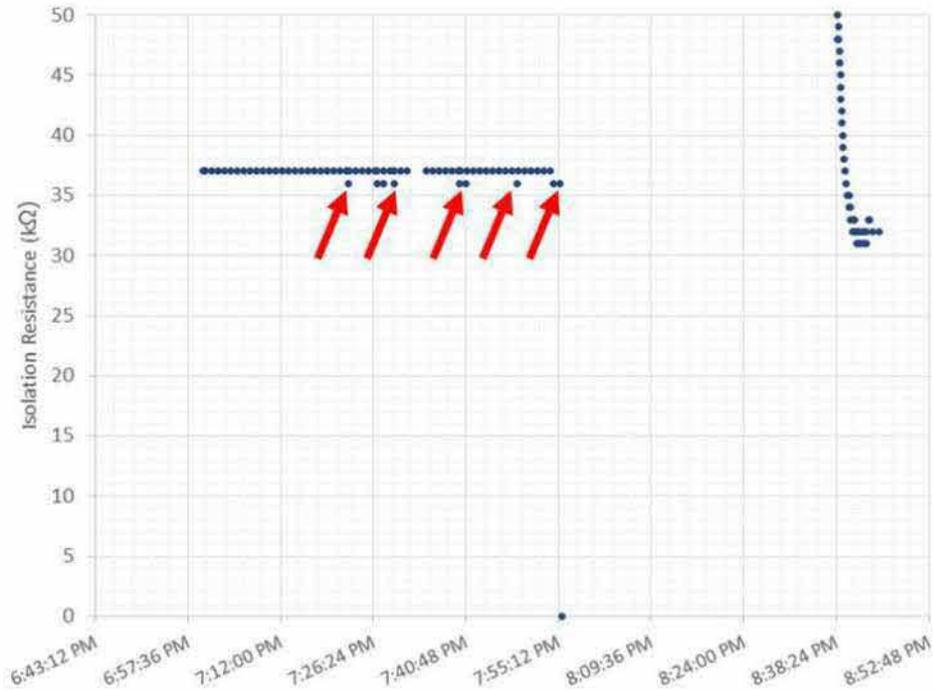
It was noted that electrical isolation excursions were reported by the IMD before and during the failure event as shown in Figure 42.<sup>17</sup>

Figure 42 IMD data showing electrical isolation excursions.

The IMD resistance excursion indicates a single point electrical isolation failure or a double point electrical isolation failure. The data does not have sufficient information to distinguish between a single or a double point electrical isolation failure event. This suggests that the cell stack was not floating freely and electrical isolation between the cells and Rack 15 frame was momentarily compromised before and during the failure event. This evidence further supports an electrical isolation failure between modules 1-7 and modules 8-14. Exponent is aware of prior IMD electrical insulation resistance excursions, and these need to be further investigated.

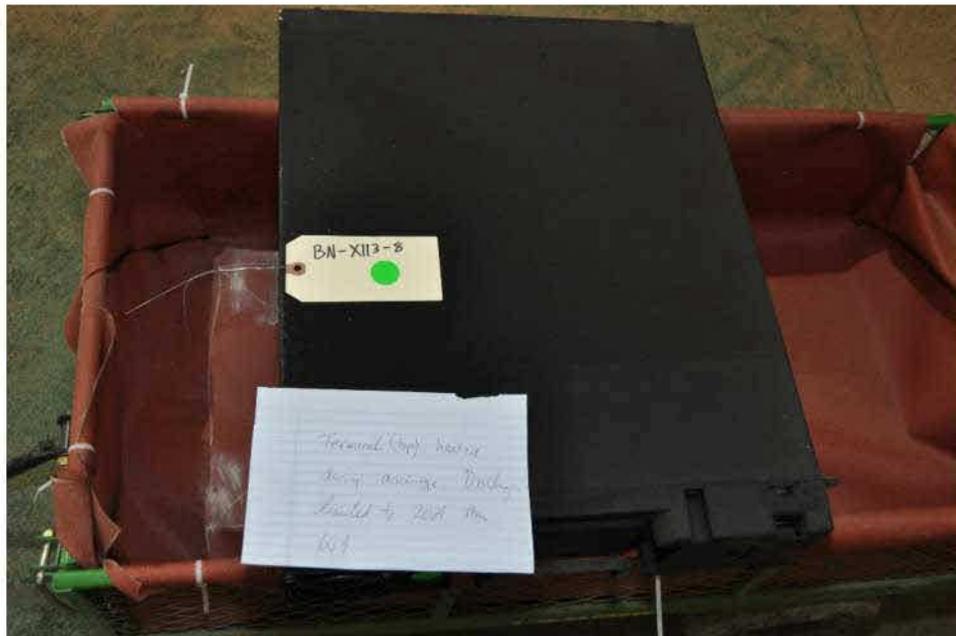
Figure 44 Module 8, Rack 13.

During discharge it was noted that the Rack 13, module 8 (see Figure 44) positive terminal heated during discharge. The module discharge current was reduced from 64A to 20A to maintain a terminal temperature at or below 50°C. The module was inspected but the terminals could not be inspected as they were covered. It was also noted that the Rack 17, module 7 positive power terminal heated to 40°C during discharge of the module. The cause of the terminal heating was not investigated.

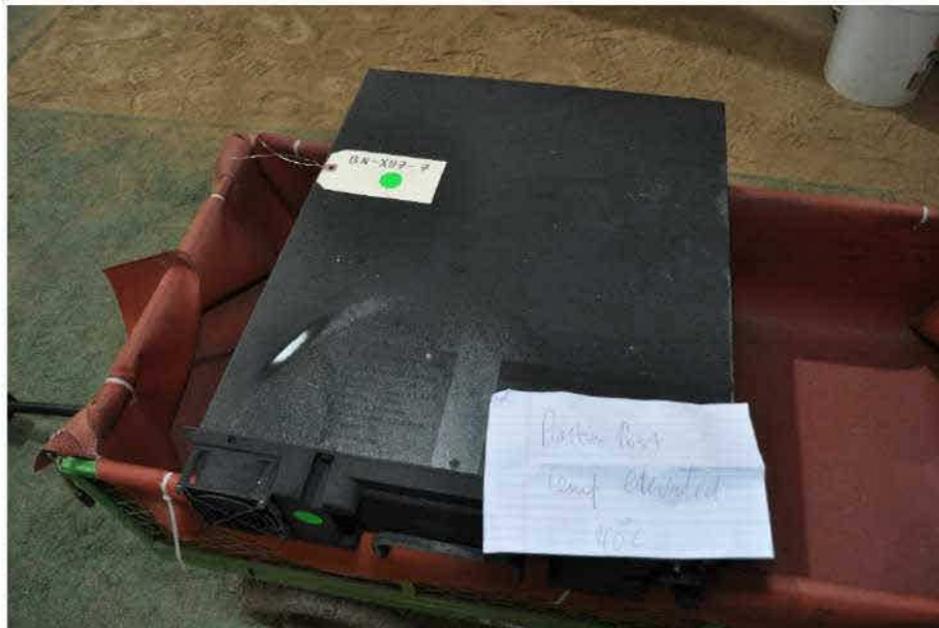
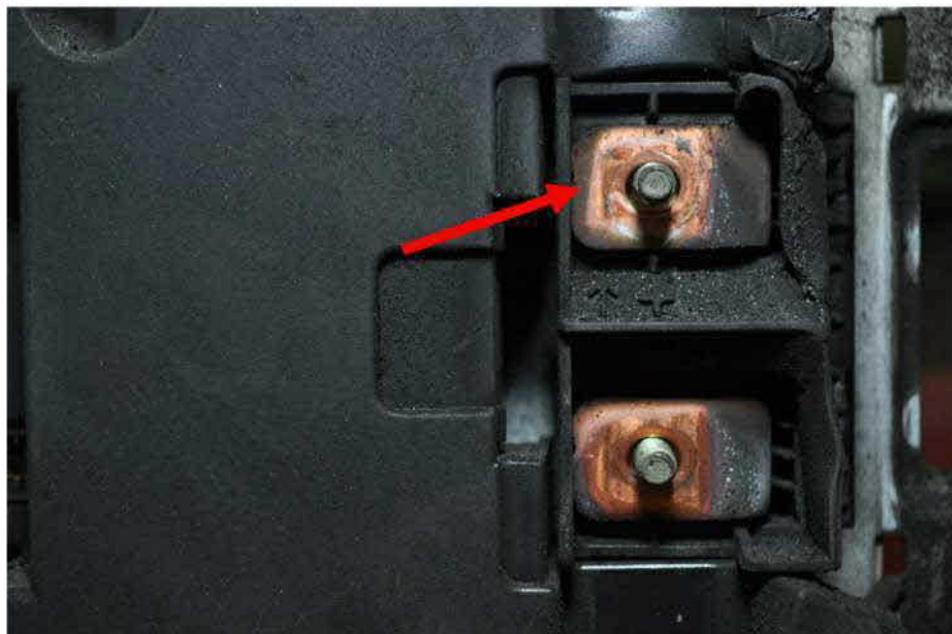
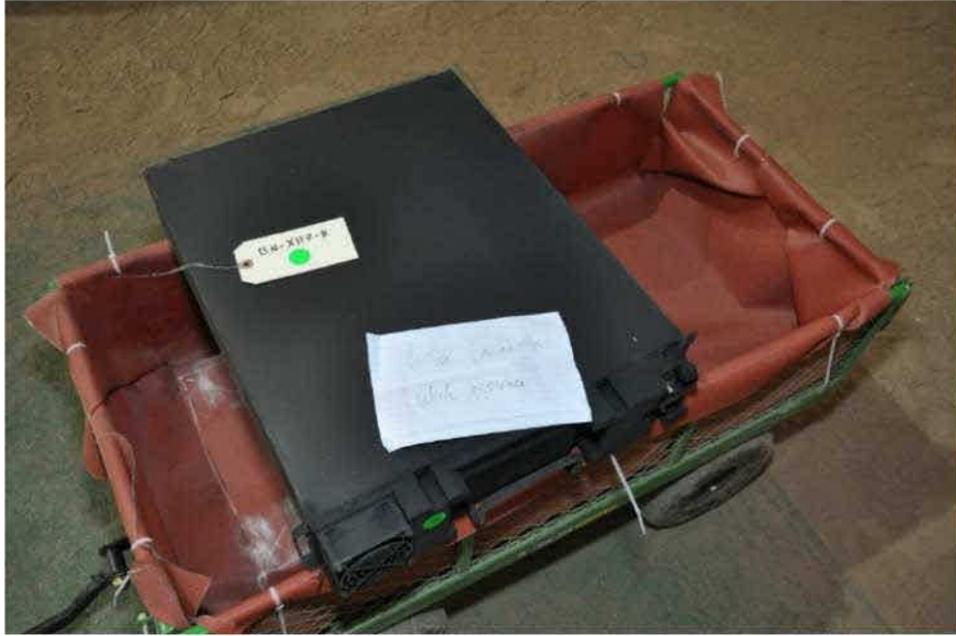
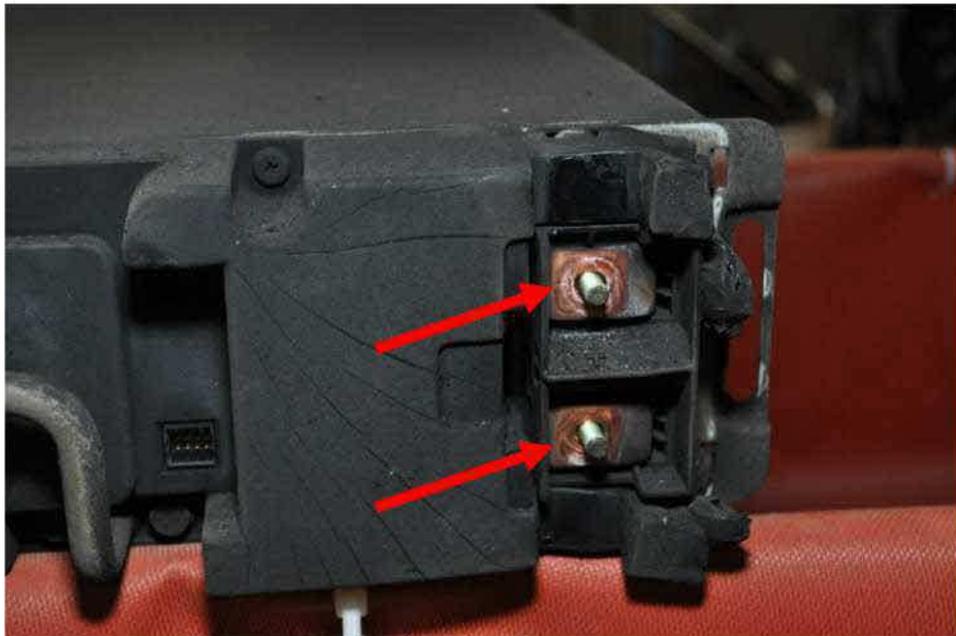
White residue was observed on several modules including Rack 17, modules 7 and 8 (see Figure 45 and Figure 48). Module terminals in Rack 17, for example modules 7, 8 and 9 showed

evidence of a white residue at the contact area of the positive terminal. This observation was not consistent across all the module terminals. Rack 13 could not be inspected because the terminals were covered.

- Two modules showed an elevated positive terminal temperature during discharge. It was noted that a white residue was present on the positive terminals on three of the modules, including a module that showed elevated positive terminal temperature. The cause of the terminal heating and white residue were not further investigated.

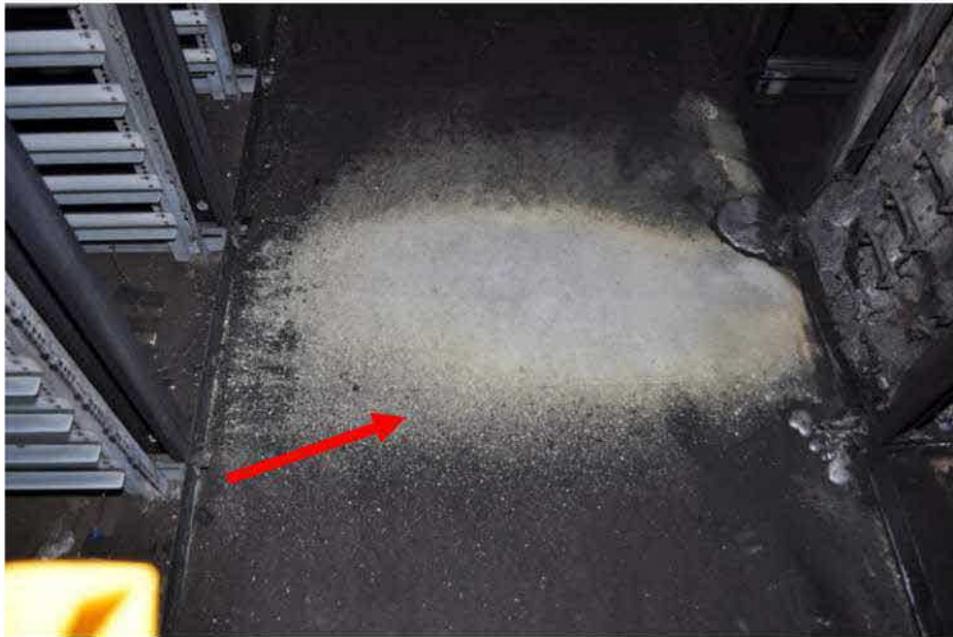
Inspecting the face of the rack showed an interesting feature on the floor. There was an oval section of the floor right in front of the rack, exposing the original floor paint (see Figure 55). This suggests that debris covered the floor prior to soot coloring the floor.

Figure 55 Floor in front of Rack 15.

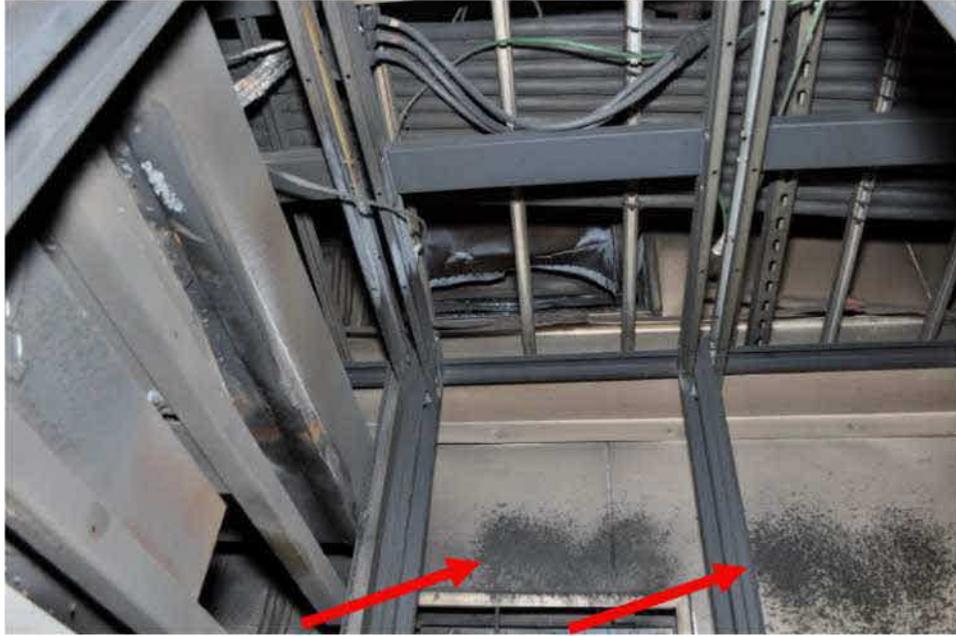
Spatter could be observed on the wall. The spatter coincided with the location of the inverter fans. Inspection of the inverter fans showed the fans were clogged with debris (see Figure 56 and Figure 57).

Figure 56 Wall behind the racks.

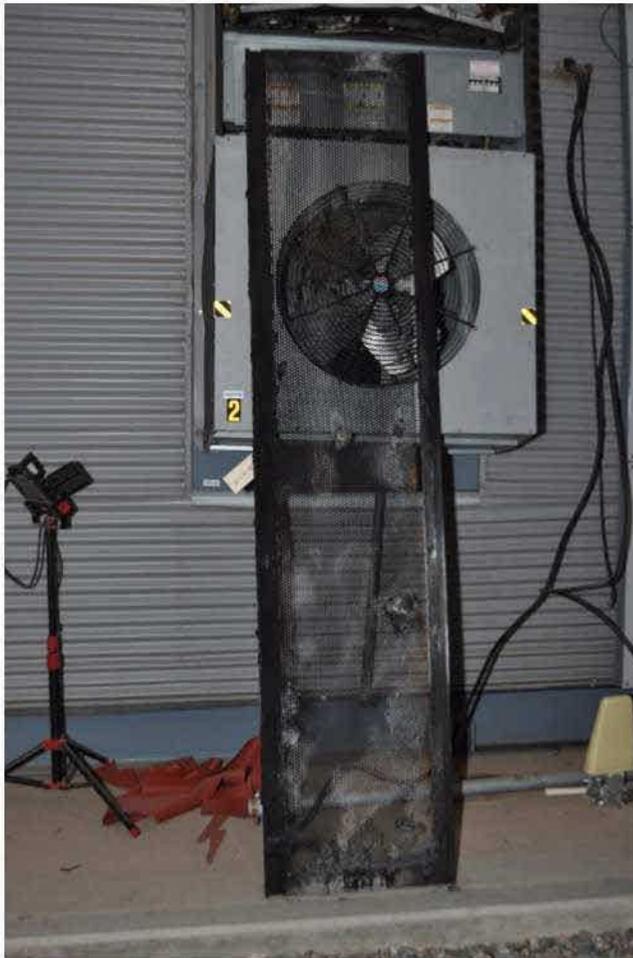
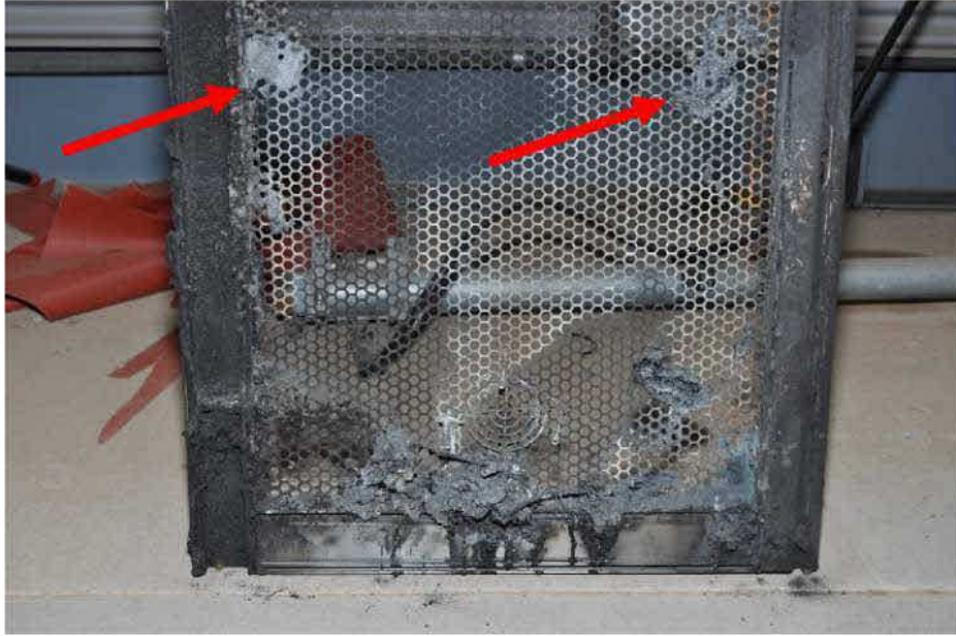
The door was removed and inspected (see Figure 58 to Figure 60). Debris of an unknown source was observed to be attached to the screen of the door in the general location of module 3's fan and power terminals.

Once the door was removed the front panels of the modules in Rack 15 could be inspected. It was noted that debris could be observed on the screen of the door, including in the general area of module 3's fan and power terminals.

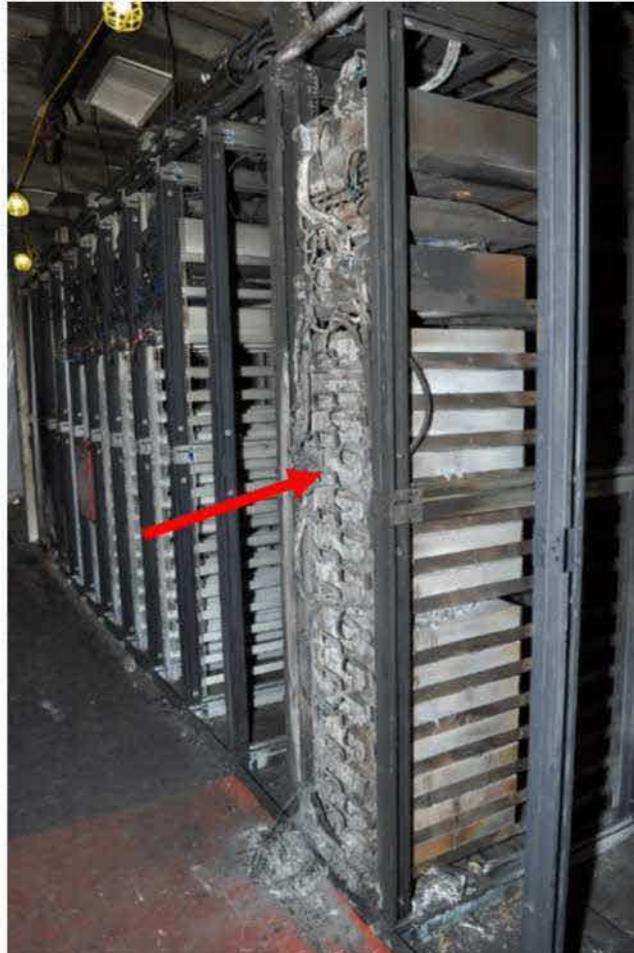
Figure 61 Rack 15, module 11.

Inspecting the exposed sides of the modules showed evidence of melting, perhaps associated with arcing on the right side of module 11 (See Figure 61). The reason for the melting of the case is not known. The left sides of the modules were intact. It was noted that the external busbar of module 3 at the positive power terminal was electrically open and appears to be arc damaged (see Figure 62).

- Module 11 showed melting damage on the right side of its enclosure, likely due to arcing between the internal negative busbar and the aluminum enclosure.

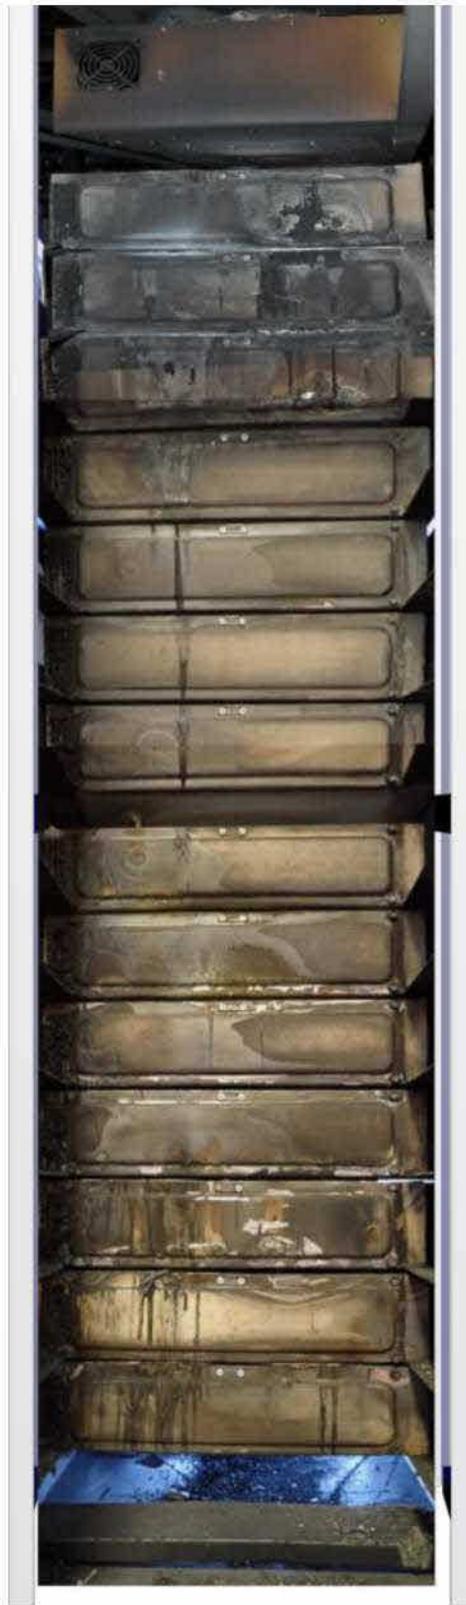
On rear covers of the modules there were interesting artifacts (see Figure 63). Modules 2, 3, 7, 8, 11, 13 and 14 show circular artifacts on their rear covers. All the artifacts seem to be independent to the specific module, except in the case of Module 3 and Module 2, which seem to share the same artifact. Black plastic drippings were observed.

Figure 63 Rear module covers of Rack 15. Module 1 is at the bottom and module 14 at the top below the BPU.

Modules 12, 13 and 14 show significantly more soot damage compared to the remaining modules.

- The cause of the artifacts observed on the back covers of the modules, are likely due to the expansion of the cell stack and the resulting cell and or sense conductors touching the grounded enclosure. This observation indicates that the cells in Rack 15 were not electrically floating (electrically isolated from the rack frame) at the time the arcing occurred. This is likely more evidence that the electrical isolation was breached prior to the arcing to the module enclosures and rack frame events.

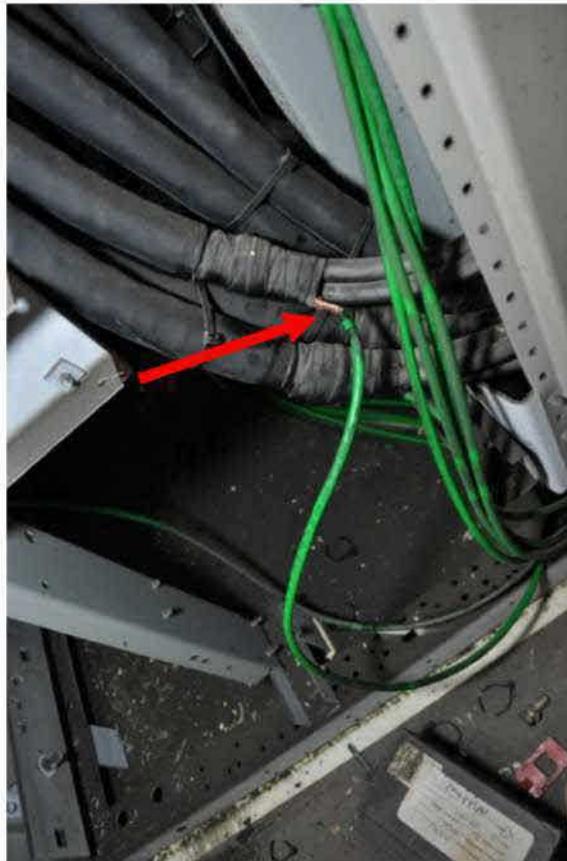
The wiring from Rack 15 to the panel was inspected. The power cable was a shielded power cable. It was noted that the rack power cable ground shield was connected to ground at the rack frame but at the panel the rack power cable shield did not seem to be electrically connected (see Figure 64). It is not known what effect this will have on the system common mode noise.

Figure 64 Rack 15 power cable ground conductor.
