**LG Chem, Ltd.**

July 30, 2020

**RE: In the Matter of the Commission's Inquiry of Arizona Public Service Battery Incident at McMicken Energy Storage Facility Pursuant to AZ Administrative Code R14-2-101. (Docket No. E-01345A-19-0076)**

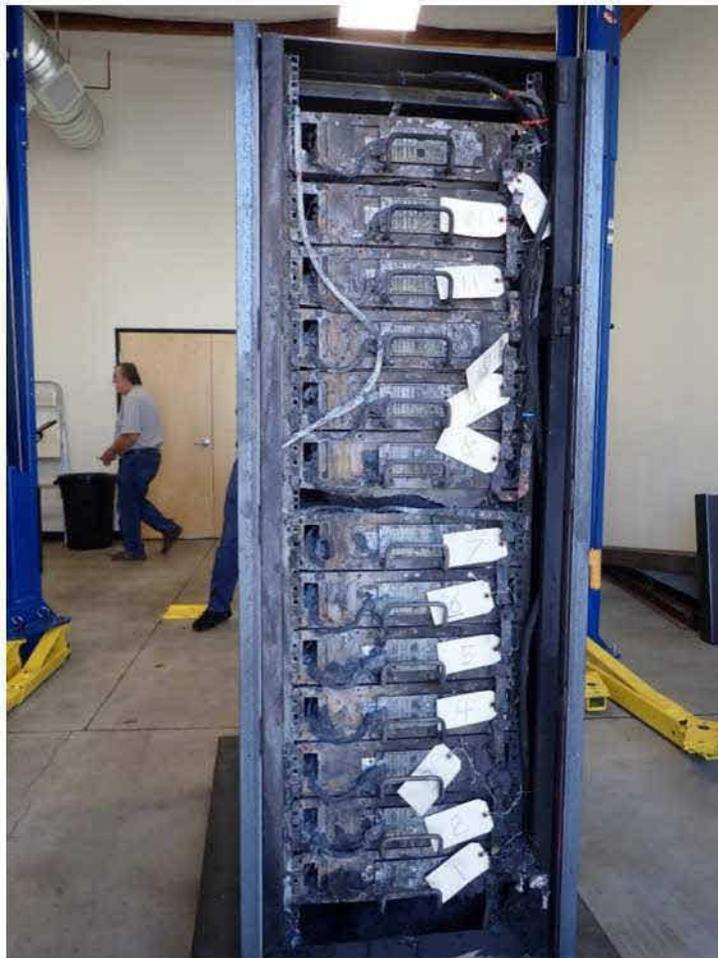
The rack was then disassembled by removing the front cover as shown in Figure 66 with the modules tagged.

Figure 66 Rack 15 with front cover removed.

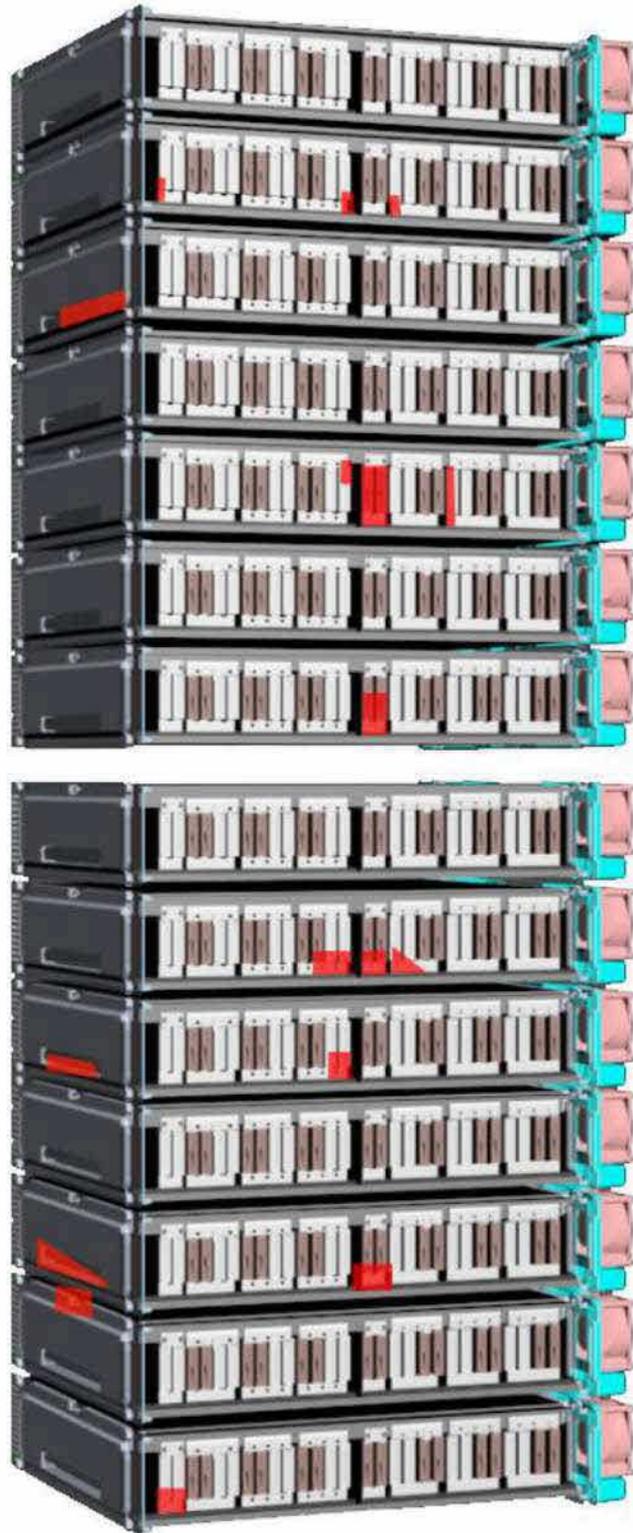
Figure 68 Rear and left side of Rack 15. The red marked areas show the arcing at module rear plates, internal busbars and cell tab interconnects.

Arcing to the module enclosure shows evidence that the rack was not floating or isolated at the time the arcing occurred. The arcing was mapped as shown in Figure 67 and Figure 68 using red blocks indicating the location and extent of the arcing.

- The arcing did not show the origin of the event.
- The arcing patterns in the modules and rack do not provide sufficient evidence to support a single cell failure event as the root cause of the rack fire.
- The arcing to the rack frame and the module enclosures indicates that the cells were not electrically isolated from the rack at the time the arcing occurred.
- The arcing is predominant in the front right side of the modules.
- Module 3 positive terminal sustained severe arcing damage.
- In Module 2, Cell 14 arced to the front metal cover plate and Cell 7 in Module 2 arced to the rear lid securing tab.

Rack level failure testing needs to be performed to understand arcing behavior and patterns.

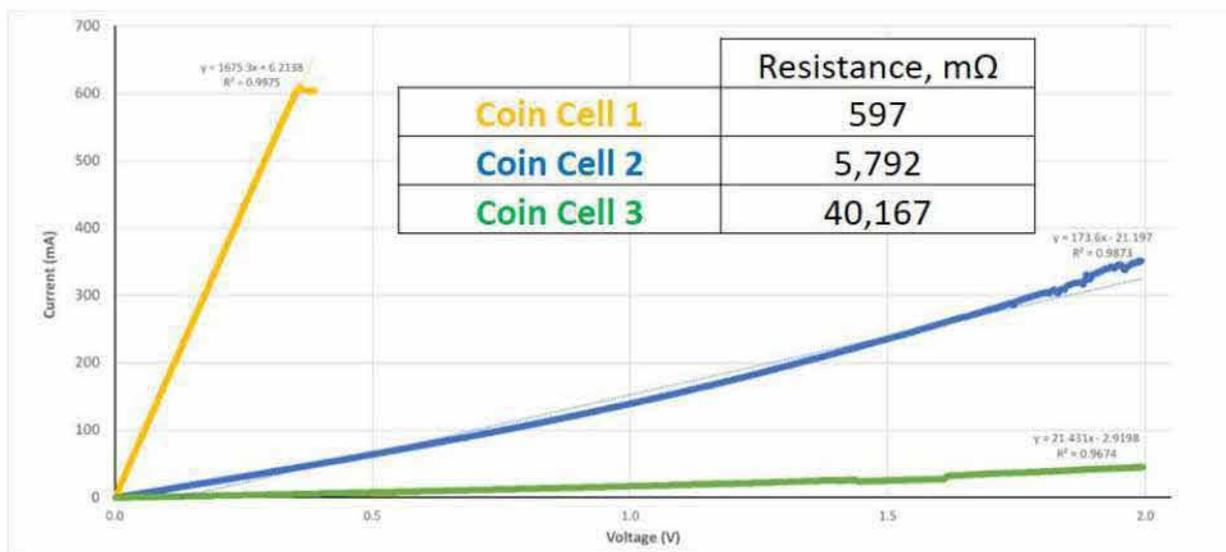
Figure 75 Voltage – Current relationship for three different samples during a Voltammetry test.

Figure 75 shows the measured current as a function of the applied potential for each coin cell. These results were used to fit the internal resistance of each coin cell using Ohm’s Law. The internal resistance of each coin cell is the inverse of the slope of the Voltage – Current relationship. The substantially increased impedance does not support characterization of the deposit material as pure lithium metal. As was stated before, it is impossible for a non-conductive deposit to carry current, resistively heat and cause thermal runaway

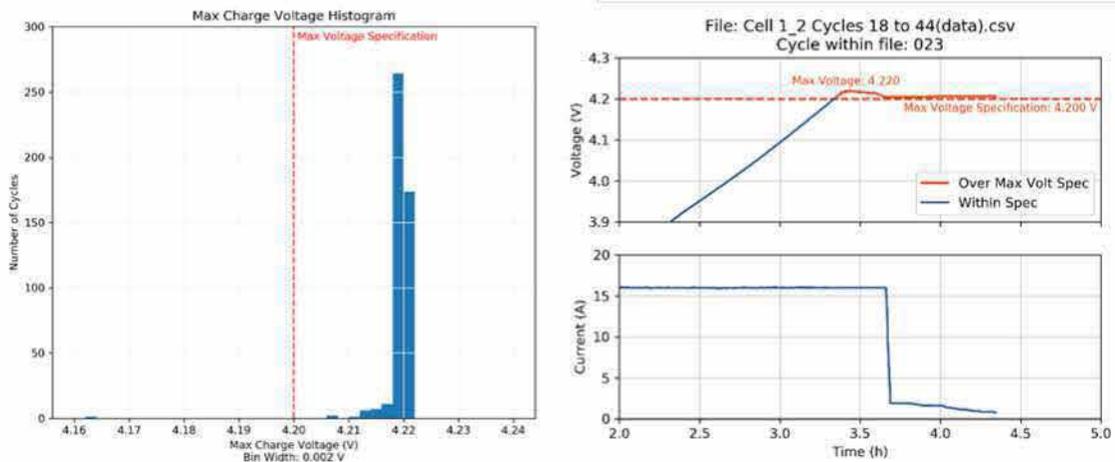
First, the charge voltage consistently exceeded the maximum charge voltage specified by LG Chem<sup>25</sup>. Figure 80 (a) clearly shows that many cycles exceed the maximum charge voltage, in most cases by at least 18mV. Figure 80 (b) shows the charge voltage and current for a typical cycle exhibiting overvoltage behavior. During a properly functioning charge test, the charger should transition from a constant-current (CC) charge to a constant-voltage (CV) charge as soon as the cell's voltage reaches the voltage upper limit. This should result in the voltage holding at the upper voltage limit throughout the CV charge, during which time the current should smoothly decay until reaching the end of charge. SEL's data do not follow this behavior; instead, the data indicate that the charger continued to apply a constant current voltage while the cell was above the upper voltage limit. This continues for approximately 20 minutes in most cycles. At the end of this period, the current rapidly falls to a small fraction of the constant current value and the voltage declines slightly, approaching (but remaining above) the upper voltage limit. These results suggest that the equipment SEL used for this cycling test was not designed for and was simply incapable of accurately performing an ordinary charge algorithm on this cell.

Figure 80 (a, left) A histogram of the number of cycles that had various max charge voltages. (b, right) Current and voltage profiles for the end of charge for a typical cycle exhibiting overvoltage on charge.

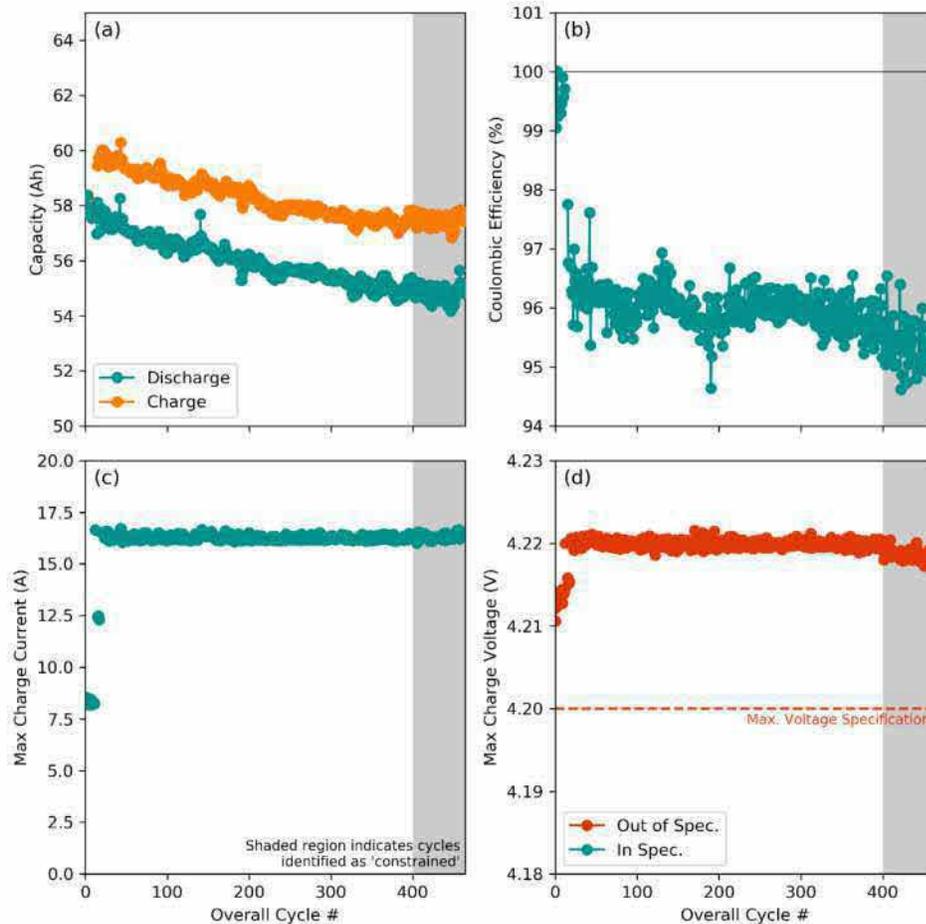
The coulombic efficiency (discharge capacity divided by the previous charge capacity) also undermines the test results. Lithium-ion batteries cycled under consistent conditions maintain a coulombic efficiency very close to 100% (often greater than 99.9%). Figure 81 (b) shows that the coulombic efficiency changes with the changes in the charge conditions; early cycles (with charge currents of 8.2 to 8.6 A) have coulombic efficiencies of 99% to 100%, consistent with cells operating normally. After the charge current was increased to 16.5 A, the coulombic efficiency dropped to 96% for the remaining cycles. Figure 81(a) shows that the change is entirely due to the changes in the measured charge capacity on each cycle. This indicates that the equipment SEL used to cycle this cell was either inaccurate, improperly configured, or incapable of performing this test.

Figure 81 Various cycling performance metrics by cycle number: (a) charge and discharge capacities of complete cycles, (b) coulombic efficiency, (c) maximum charge current, and (d) maximum charge voltage.

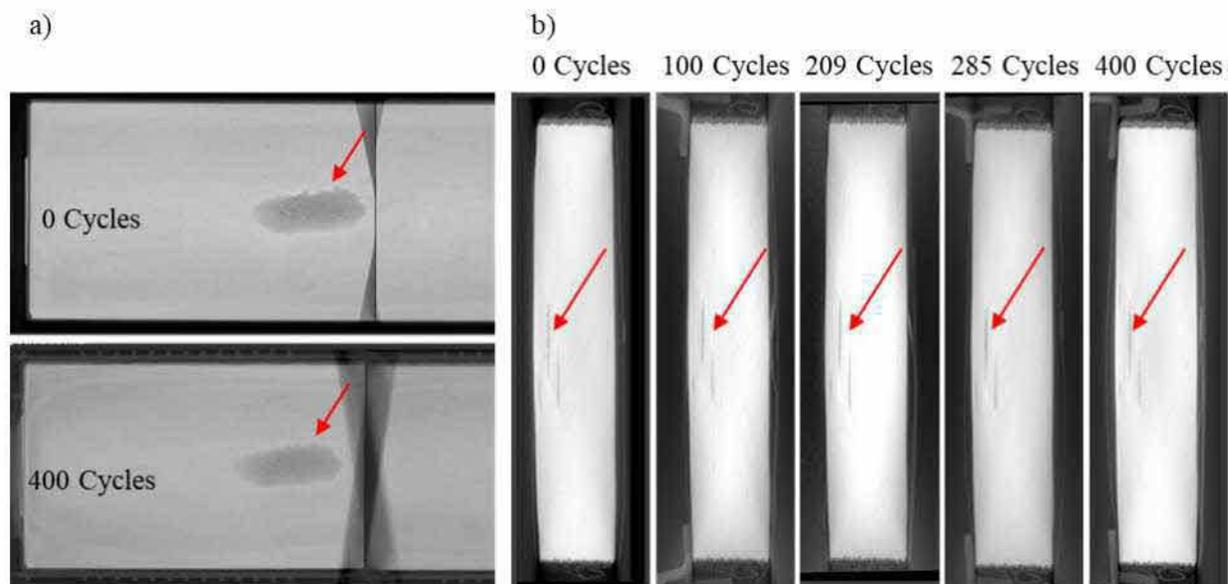
Figure 82 (a) Planar and (b) cross-sectional views of one representative feature tracked throughout cycling.

The uncycled cell contained several features consistent with deposits on the negative electrode, similar to those found to be non-conductive (as discussed above). These features did not change in size or shape during the 400 cycles, see Figure 82. Additionally, despite the issues with the cycling protocol noted above, no measurable swelling of the pouch or localized swelling around the deposits were observed over the 400 cycles tracked. This data does not support the growth of the internal cell features as a function of cycle count.

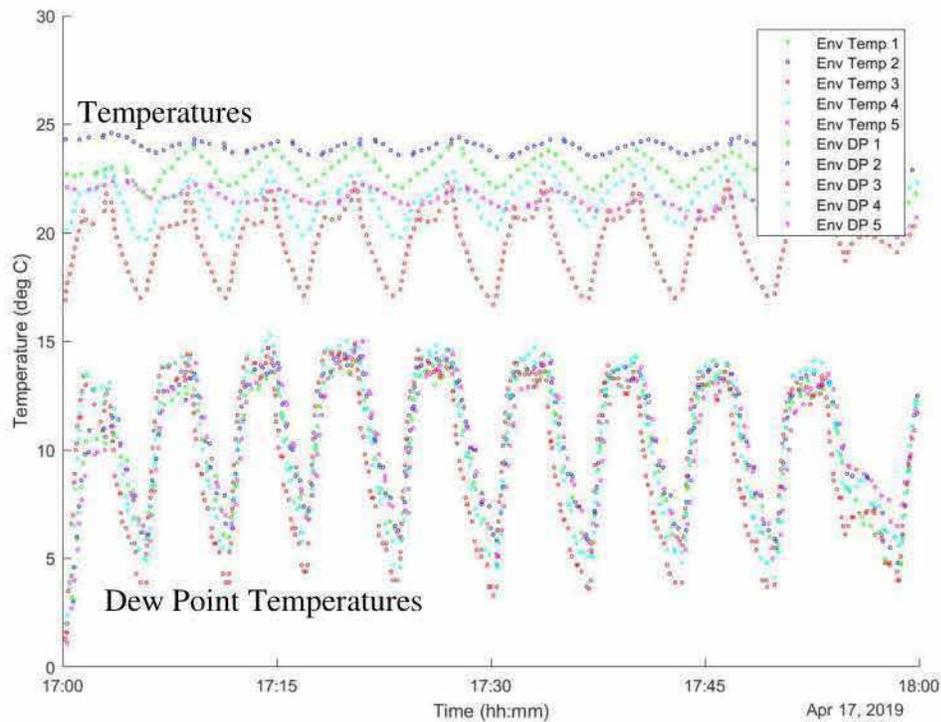
Figure 83 Environmental temperature measurements and dew points at the five measurement locations approximately two days prior to the incident.

The upper five traces correspond to environmental temperature measurements. The environmental temperature sensor three, which is closest to Rack 15 (see Figure 84, NetBotz: Container Temperature), is the coldest of the five measurement locations during the measurement window. The range of measured temperatures at specific times is up to approximately 7°C (12.6°F difference). Given that the sensor locations are not aligned with the HVAC cold air supply ducts, the spatial resolution is insufficient to understand the full range of temperatures experienced by the modules. To illustrate the presence of large temperature gradients, the sensor across the aisle at nearly the same location is measuring approximately 4°C (7.2°F difference) warmer at times. Temperature differences on the order of 1-2°C were also observed between the PLC sensor #4 and the environmental temperature sensor #3, and they are in the same or similar location.

The lower five traces in Figure 83 are the dew point measurements at each of the locations. The dew point is the temperature at which water vapor begins to condense into liquid water. The higher the dew point, the more water vapor molecules are in the air. The dew point at all five locations tends to decrease during cooling phases, which indicates drying of the air at the evaporator coils. The Marvair Model AVPA72ACD060CU A5-200-VAR HVAC units have a drain pan below the evaporator coils to collect condensation, and a discharge port to the right side of the drain pan (as viewed from the outside front of the unit) to route the condensation outside of the HVAC and BESS (see Figure 85). The dew point rises after each cooling phase, suggesting that there is a source of moisture either inside the BESS, or outside of the BESS which is entering the BESS. The available data indicates that the BESS is not a closed system with regards to moisture infiltration as it was reported to be. The source of the moisture has not been determined to-date.

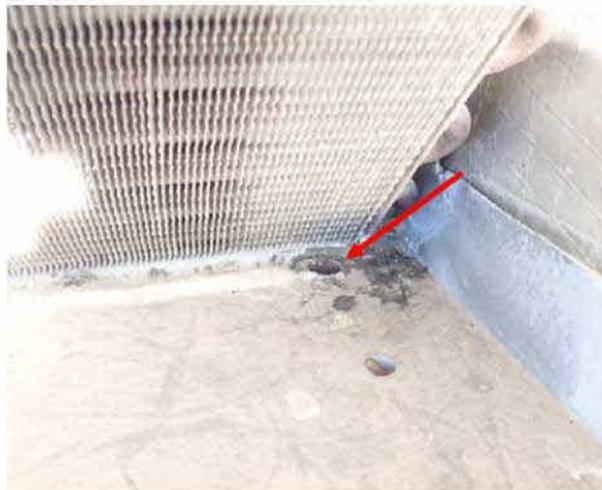
Figure 85 Drain pan discharge port below the evaporator coils.

Possible sources of moisture prior to the incident include a liquid water leak from rainwater or condensation from HVAC #3, or the entrance of water vapor through the HVAC economizer dampers which may have allowed humid outside air to enter the BESS. Economizers, if configured properly, utilize outside air under specific circumstances to condition air in the BESS instead of running the compressor in order to lower energy consumption.

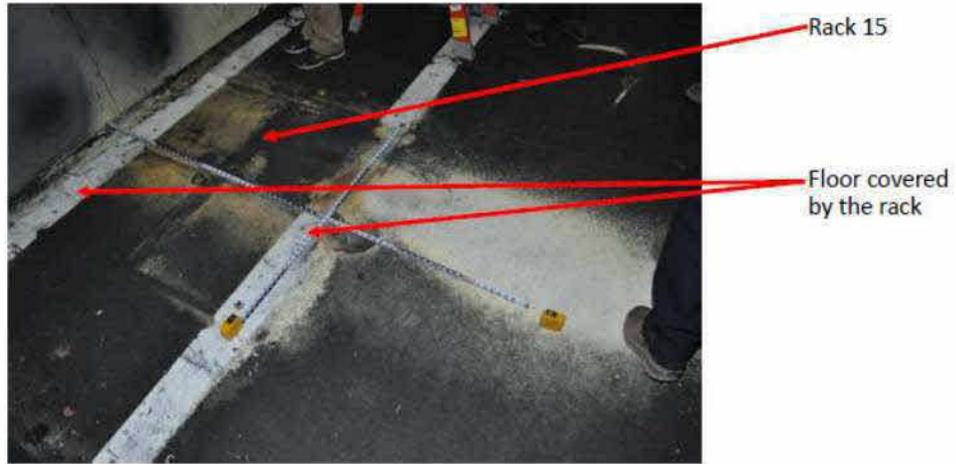
Evidence of liquid marks were observed on the inside face of the HVAC #3, which mates with the exterior wall of the BESS (see Figure 89). Additionally, below the same return air cutout, drip marks were observed on the inside wall of the BESS (see Figure 90). The drip marks on the inside wall of the BESS appear to align with the spout formed by the bend in the corner flashing in the HVAC. This bend likely occurred as a result of the explosion, and therefore the drip marks on the inside wall of the BESS likely occurred after the incident. Dried liquid marks were also seen underneath Rack 15 (see Figure 92 and Figure 93) and along the same wall towards the corner of the container (see Figure 91). Figure 93 shows what appears to be rust residue on the floor. If standing water is present in the BESS, it will tend to evaporate provided

Figure 92 Photograph showing the floor underneath Rack 15.

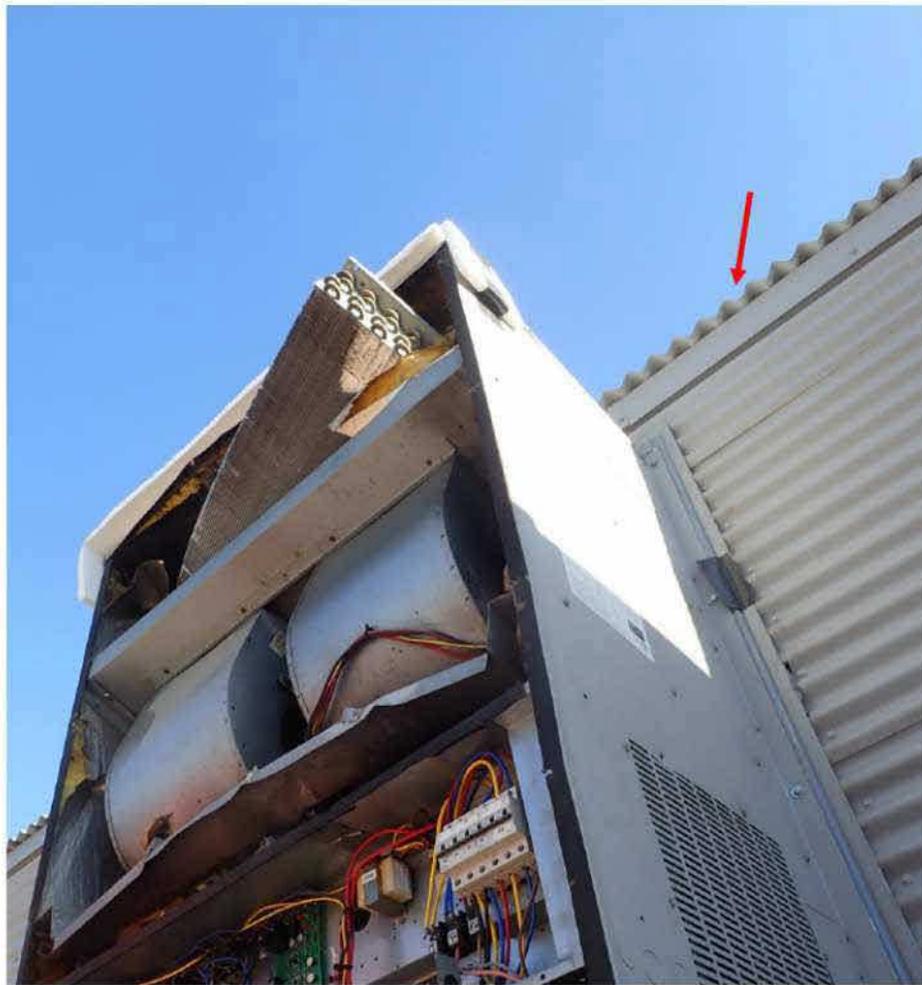
The BESS has a sloped, corrugated steel roof with the highest elevation on the southwest side, and the lowest elevation on the northeast side (the side with Rack 15). The roofing on the lowest elevation side includes an overhang so rain water runs off the roofing materials and falls to the ground (or onto the HVAC units, where it then falls to the ground; see Figure 95 showing the overhang).

Figure 95 Photograph showing HVAC #3, and the overhang of the corrugated steel metal roof.

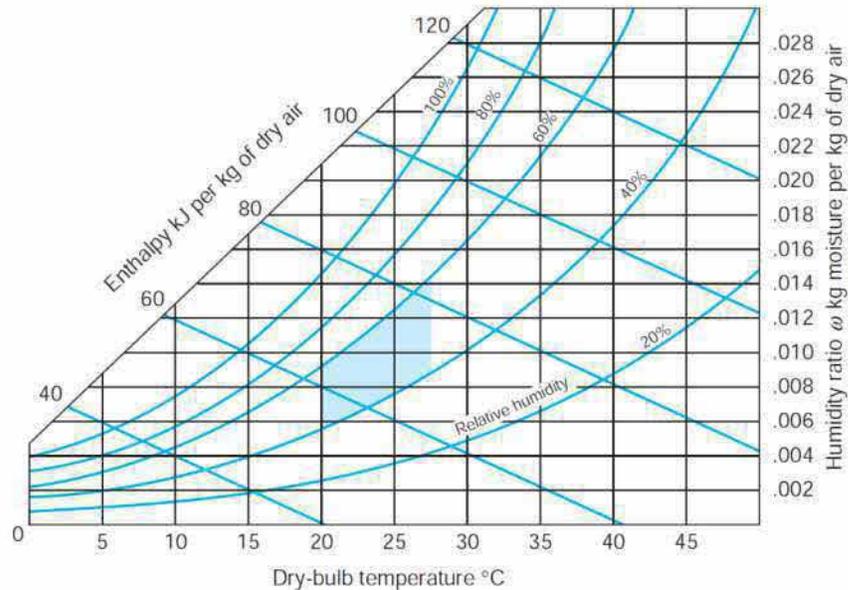
Although the measurements at the five discrete locations do not indicate that condensation occurred on surfaces in the vicinity of the sensors, the spatial resolution is inadequate for a more detailed assessment to be made. Therefore, the role of condensation on electronics in the BESS cannot be ruled out as a root cause of the initial failure. For example, the water vapor concentration will be higher closer to the source, and since the sensors are not located at the source of the water vapor, higher water vapor concentrations than shown in the data may be feasible elsewhere in the container. In the days leading up to the incident, the relative humidity data (measured at the sensor locations) reached 70-75% inside the container. At typical temperatures in the container, this moisture can condense in air and on surfaces 5-6°C cooler (see Psychrometric chart in Figure 97). Similar to the water vapor concentration phenomenon,

the temperatures may be colder in locations closest to the cooling source. There is a cold air supply duct blowing down onto the front face of Racks 13 and 15 and the nearest environmental sensors are affixed to Rack 19 and Rack 16, so the area in front of Rack 15 could be one of the colder locations within the container when HVAC #3 is running.

Figure 97 Psychrometric chart.

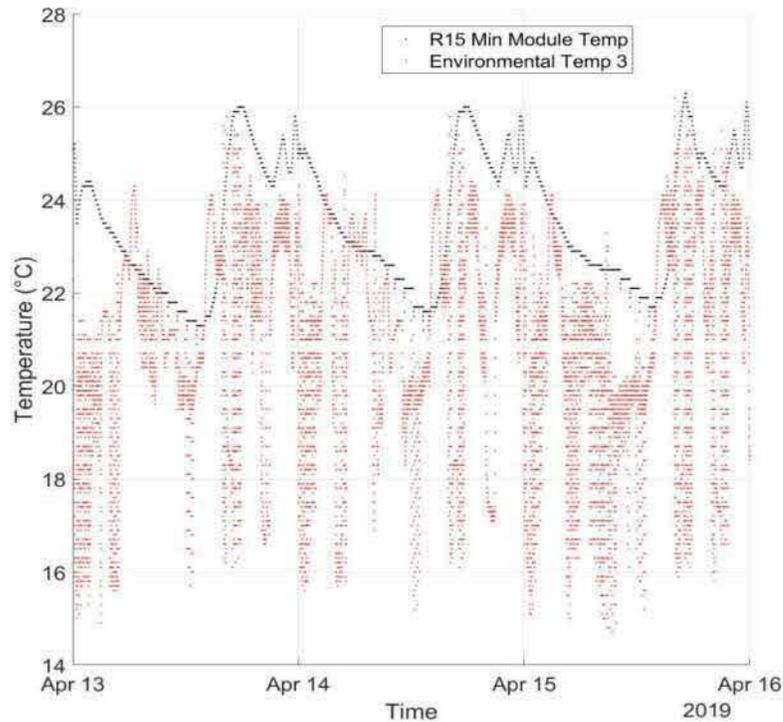
The battery module temperatures recorded by the BMS are influenced by the sensor locations, thermal properties of adjacent materials, heat generation within the modules, and the thermal inertia of the modules. The module temperature sensors are sandwiched between foam panels, which are compressed between the two submodules in the module. These temperatures will change at a slower rate than ambient air temperatures and will be influenced by heat generation and thermal transport of neighboring battery cells. Considering these effects, it is noteworthy that the measured data shows that the minimum module temperature in Rack 15 is lower than the nearby environmental sensor #3 measurement (see Figure 98) at times. If warmer, moist air from some location within the BESS were to enter colder modules, this would potentially result in condensation within the modules.

Figure 98 Plot showing that the temperature measured at the sensor three location is higher than the minimum module temperature at times.

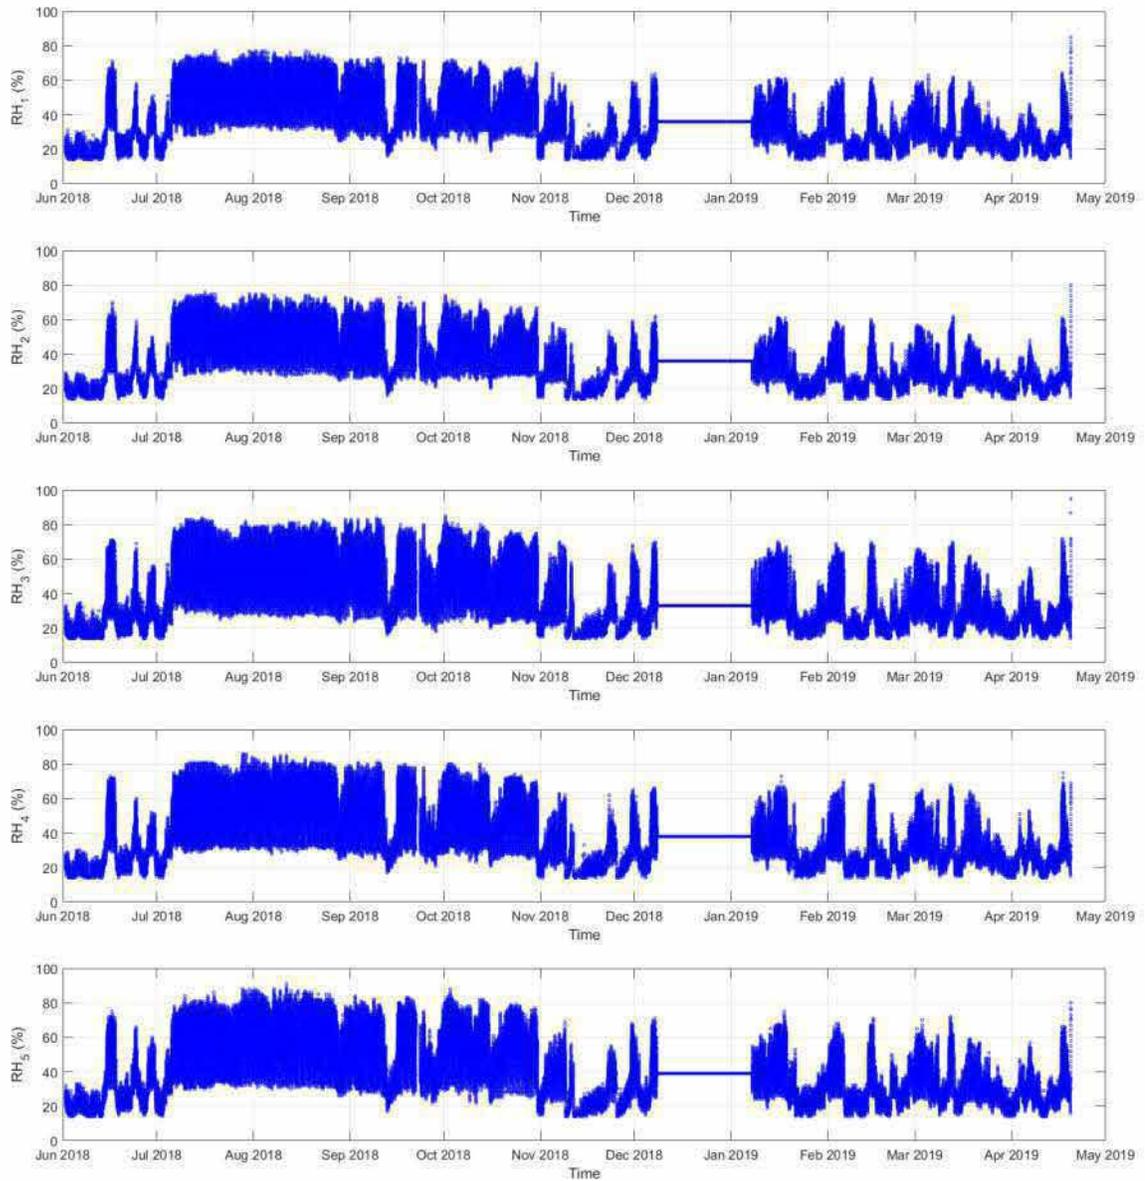
The effects of high humidity on the electronics has also not been ruled out as a potential cause or contributor to the initial failure event. Historically, the container reached relative humidity between 80-90%, including at the location of environmental sensor #3. Figure 99 shows relative humidity measurements from June 2018 up until the incident. At these relative humidities, it would only take a drop in temperature of approximately 2°C - 4°C for water to begin condensing out. For example, if 80% relative humidity air were to migrate from the environmental sensor location #3 to the colder area below the HVAC #3 cold air supply duct, condensation may occur.

Figure 99 Relative humidities measured at each of the five measurement locations between June 2018 and the incident. Note that relative humidities regularly reached to between 80-90%, including at locations near Rack 15.

- The data that is available showed that, over the history of operation of the BESS, the relative humidity consistently reached 80% or higher. The temperature at the front face of Rack 15 will be lower than what is measured at nearby environmental sensors when HVAC #3 is running because it is below the HVAC #3 cold air supply duct. This would facilitate bulk condensation or corrosion on electronics.
